Cultural Resource Assessment Survey

Lem Turner Road (State Road 115) over Trout River Bridge Replacement, Duval County, Florida

Financial Management (FM) No. 437437-2
Federal Aid Project ID No. TBD

July 2021

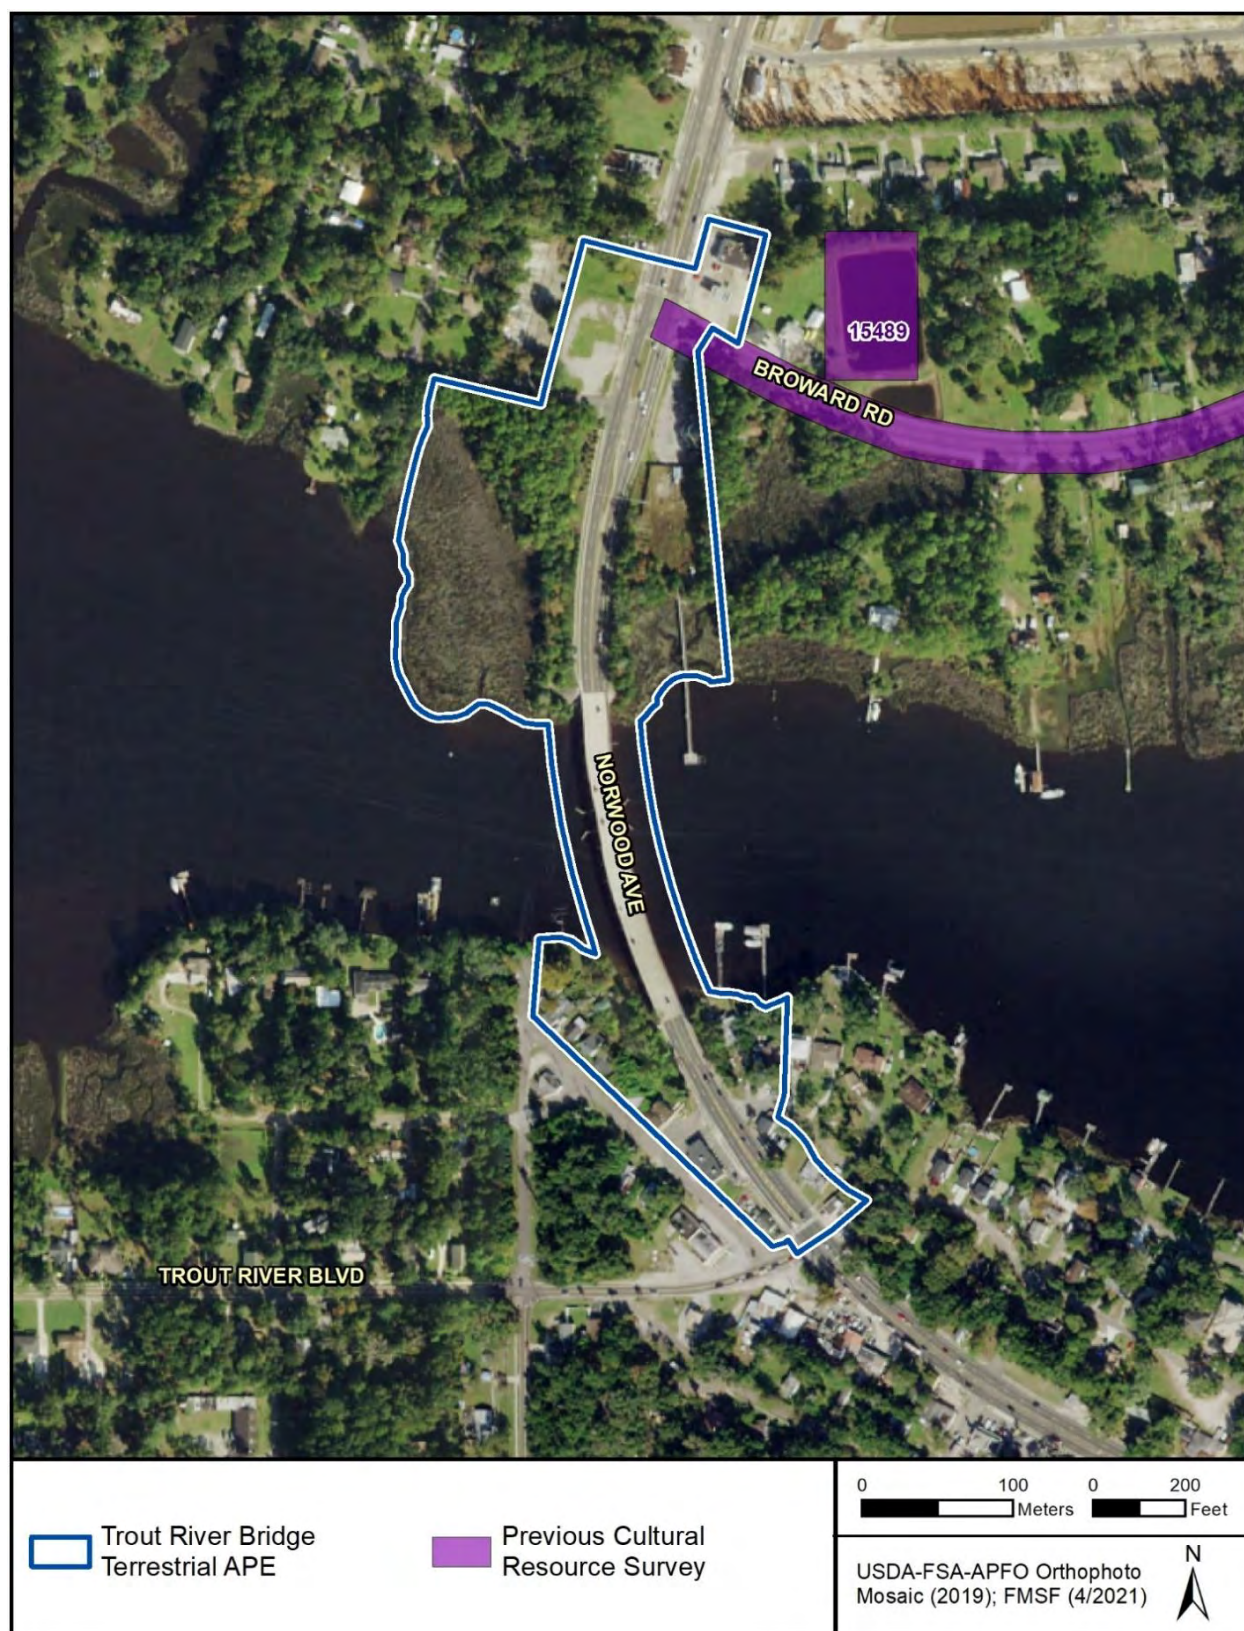
Figure 14. Previous cultural resource surveys within the Trout River Bridge Terrestrial APE.

SEARCH reviewed Florida Master Site File (FMSF) data from April 2021 to identify any previously recorded cultural resources in the vicinity of the APE. The FMSF review indicates that a portion of one previous cultural resource survey overlaps the current APE (**Figure 14; Table 2**). The survey (FMSF Survey No. 15489) intersects the current APE at the intersection of Broward Road and SR 115, although no subsurface testing was conducted within the current terrestrial APE.

No known cultural resources or archaeological sites, historic structures, or other historic resources intersect the project APE (see **Figure 14**). The nearest recorded archaeological site to the current APE is the West Branch site (8DU15989), which is located approximately 1.4 miles (2.3 kilometers) northwest of the APE. The West Branch site consists of a small lithic scatter of four prehistoric ceramic fragments over a wide area.

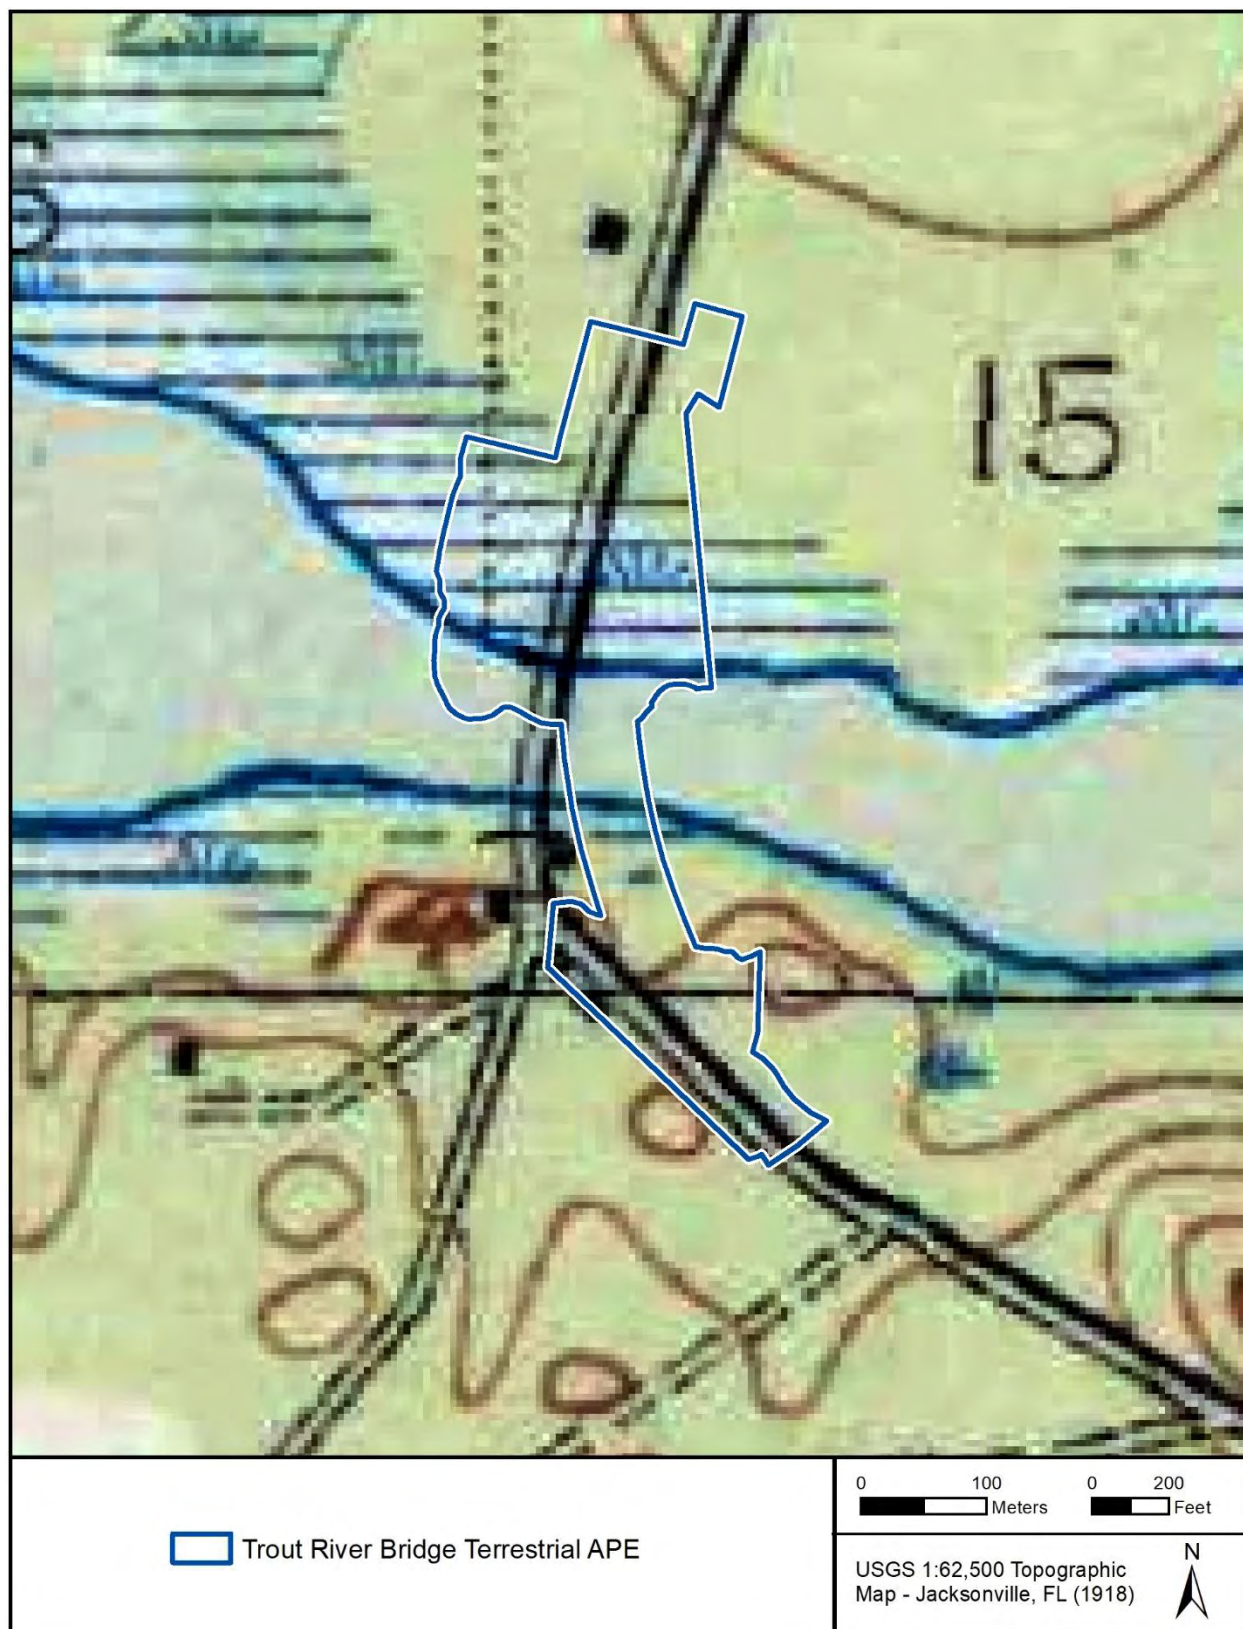
Figure 16. 1918 USGS topographic map of Jacksonville, Florida.

(Cram 1909). A topographic map of Jacksonville from 1918 finally shows significant improvements inside the APE. Lem Turner Road is evident running southwest-northeast inside the APE on the north bank of a river labeled Trout Creek where the road turns to the southeast on the south bank. A bridge is evident over the water within the APE. One structure (partially obscured by the APE boundary on the figure) is near the water on the south bank (**Figure 16**) (US Geological Survey [USGS] 1918).

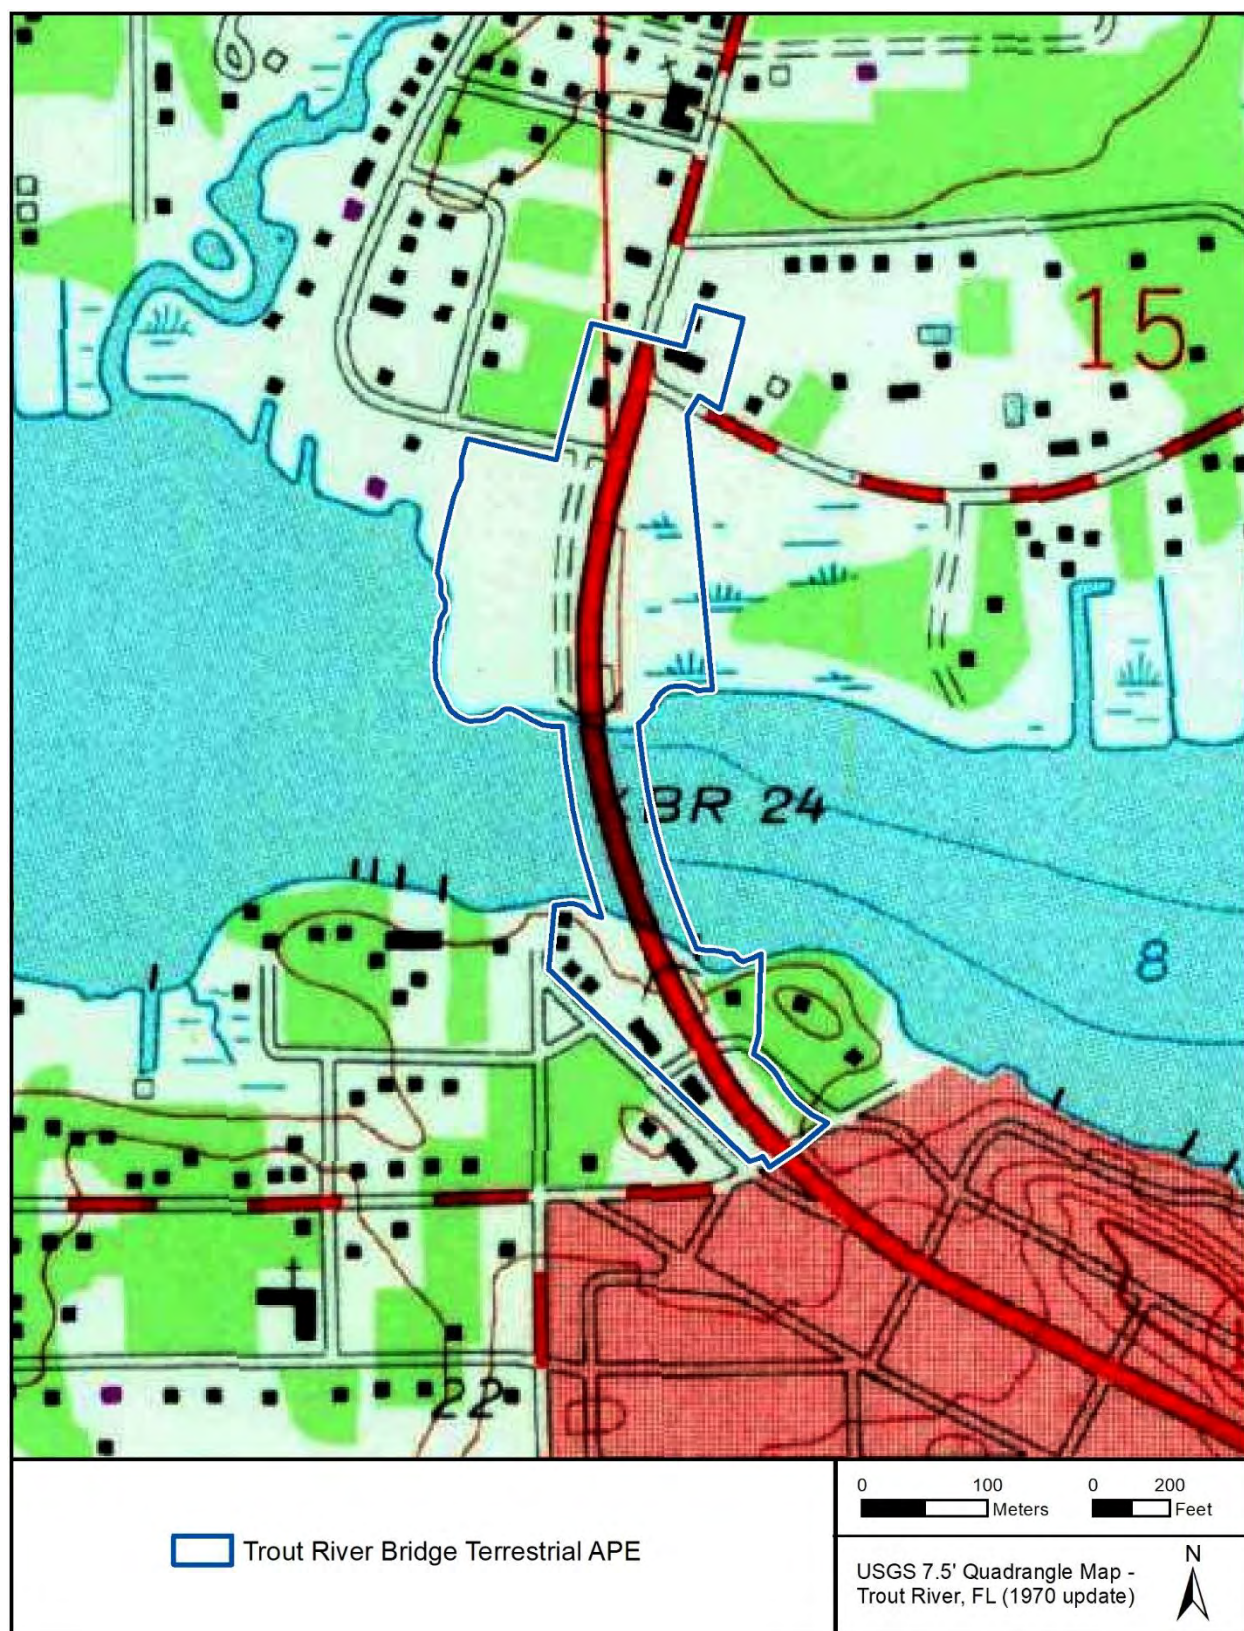
Figure 20. 1970 USGS topographic map of Trout River, Florida.

A topographic map from 1970 shows the continued development of Jacksonville on the southeast border of the APE, which borders an area shaded red to indicate high population density (USGS 1970). In the northern half of the APE, three structures are evident, and Broward Road is illustrated as an improved highway. A new east-west road is evident intersecting the APE from the west in this area. Seven structures are evident in the southern half of the APE, and the former path of Lem Turner Road/SR 115 is partially obscured by the APE border. Bayview Avenue remains evident on its current path (**Figure 20**) (USGS 1970).

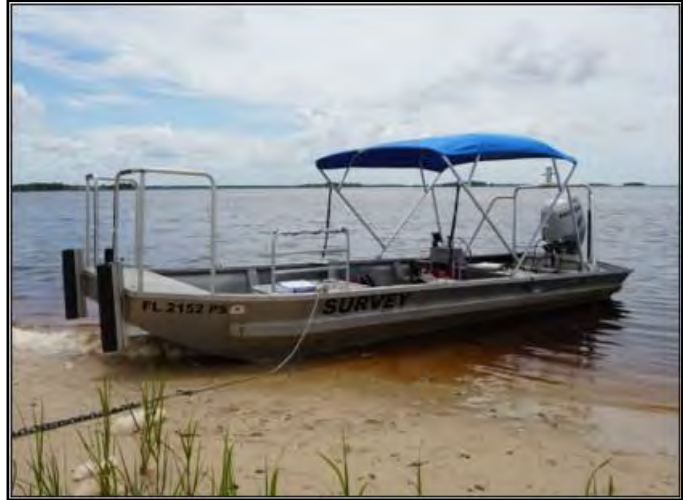
Figure 23. Survey vessel.

SEARCH conducted the survey from a 21-foot (6.4-meter) aluminum, flat-bottom survey vessel (**Figure 23**) and utilized HYPACK hydrographic navigation software and navigation charts for vessel guidance. The vessel was well suited for the riverine environment and was equipped with all necessary safety equipment, including the appropriate number of life jackets, a marine radio, horn, fire extinguisher, and visual distress signals.

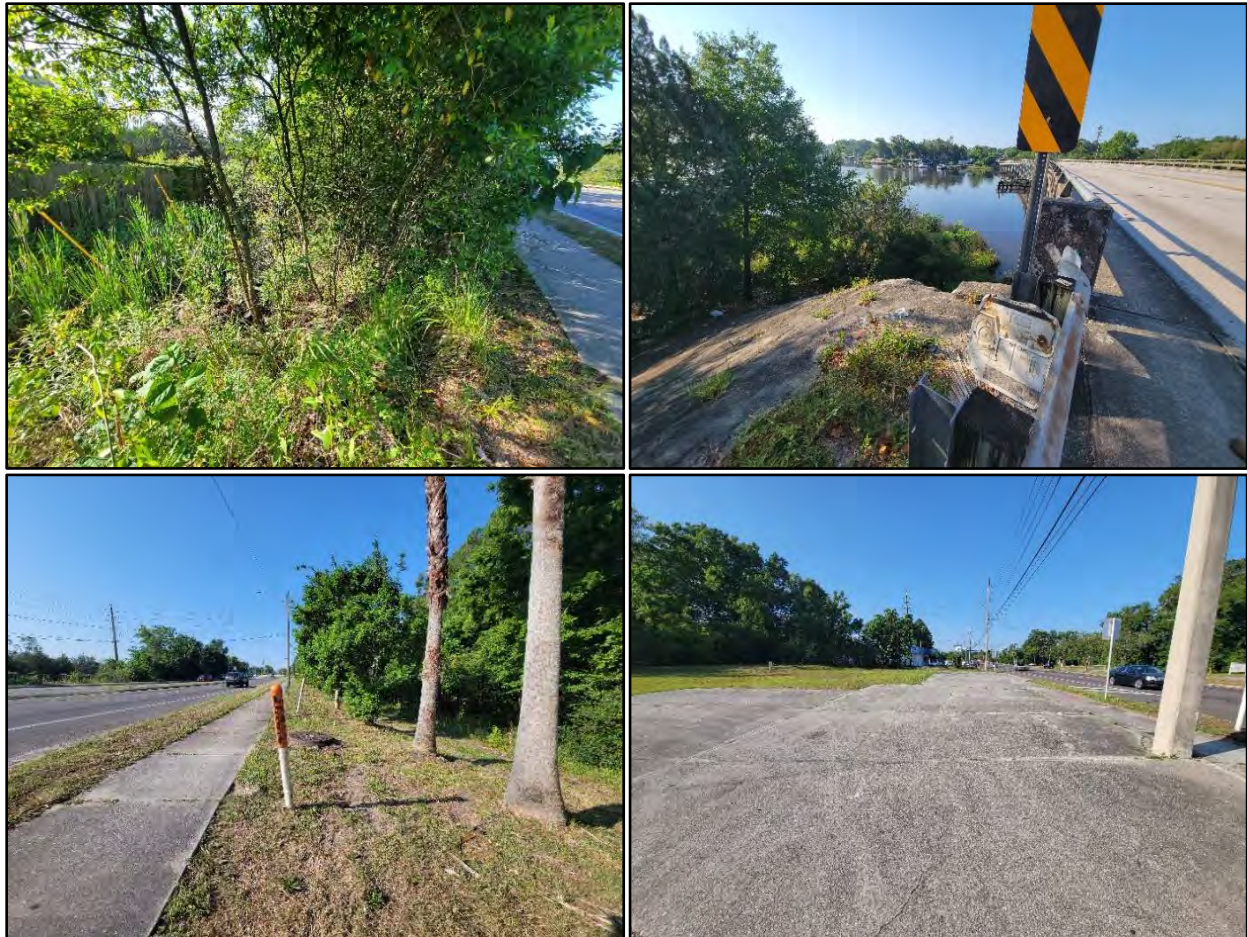
Figure 30. Typical setting within the project APE on the north side of Trout River. Top left: Wetland vegetation and sidewalk, view south; Top right: At the northeast corner of Bridge No. 720033, view southeast; Bottom left: Underground utilities and sidewalk, view south; Bottom right: Hardscape parking lot, view south.

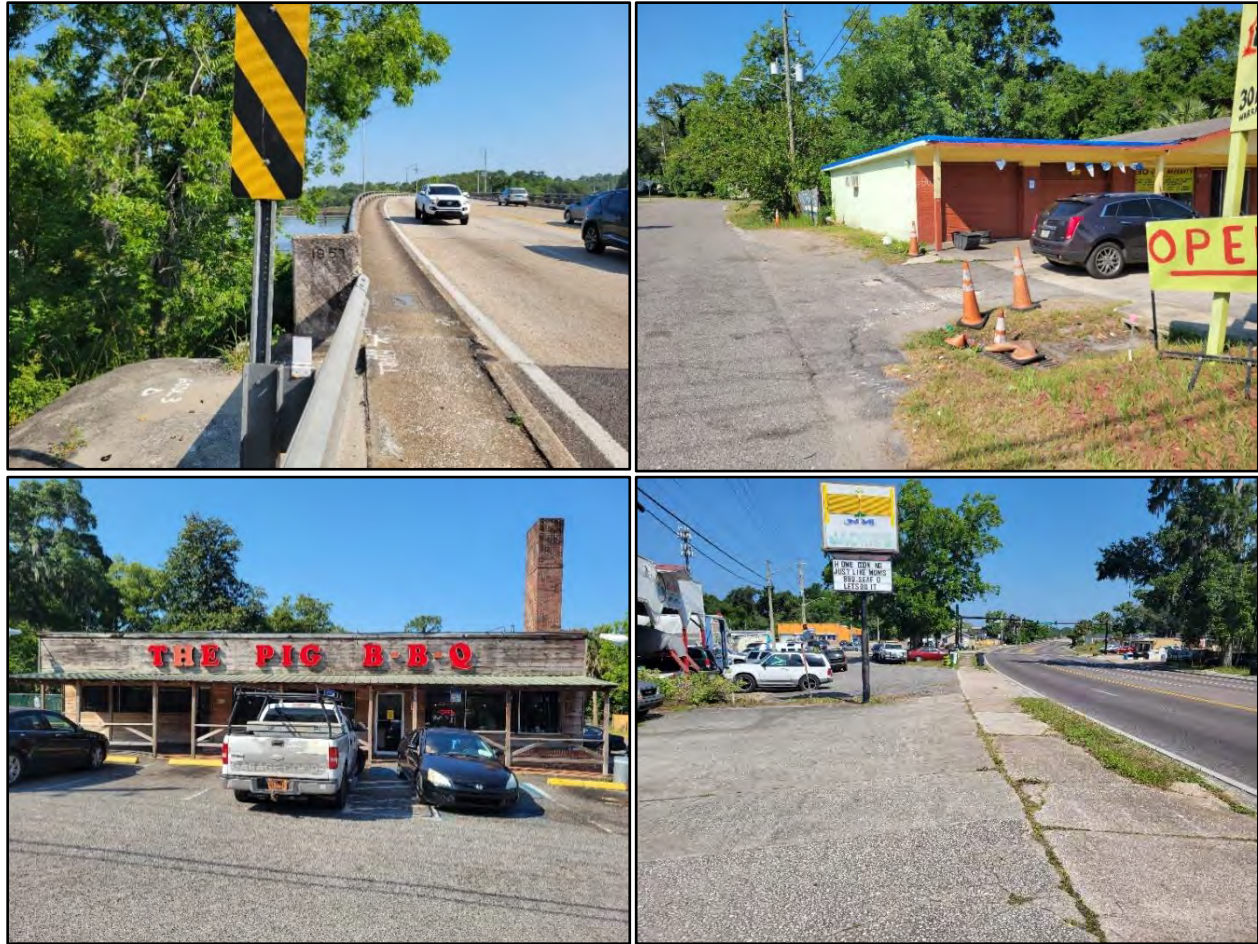
Figure 31. Typical setting within the project APE on the south side of Trout River. Top left: At the southwest corner of Bridge No. 720033, view north; Top right: Hardscape parking, view north; Bottom left: Parking lot, view west; Bottom right: Parking and sidewalk, view north.

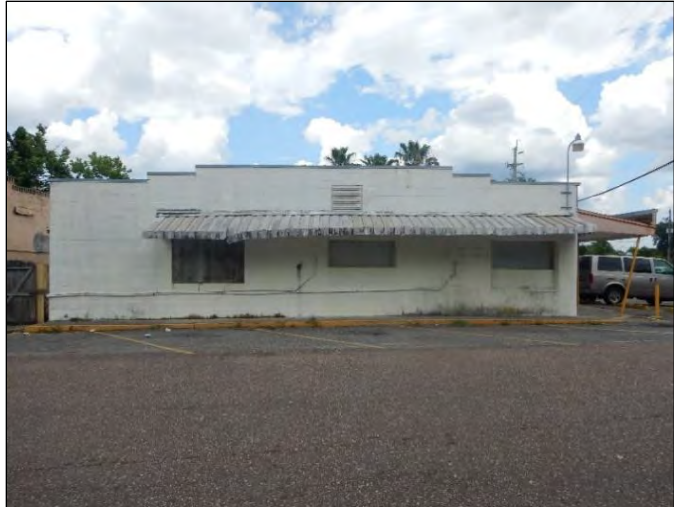
Figure 34. Resource 8DU22980 provides an example of the Commercial style within the Trout River Bridge Terrestrial APE. Photograph facing northeast.

There are three buildings within the Trout River Bridge Terrestrial APE that can be categorized as having aspects of the Commercial Style (**Figure 34**). “They are truly American architecture in conception and utility. The style is a monument to the advance of Chicago in commerce and commercial greatness and to the prevailing penchant for casting out art where it interferes with the useful (Godspeed Publishing Co. 1891:70).” The Commercial style encompasses a wide variety of buildings constructed for commercial use. Often, it is used to describe those buildings, the precursors of modern skyscrapers, constructed in the Chicago school style in the late 1800s and early 1900s. These Commercial style buildings were a product of advancement in construction technology, allowing for taller buildings (Pennsylvania Historical and Museum Commission [PHMC] 2015). Louis Sullivan, a Chicago architect, is particularly well known for his tall commercial building designs, which often included terra-cotta ornament along the lowest story and upper cornice (Harris 1998).

- Masonry exterior material;
- Large storefront windows, three-part windows, or projecting bay windows along the ground floor;
- Vertical emphasis;
- Ground floor storefront with prominent entrance;
- Steel and beam construction;
- Decorative cornice; and
- Flat roof (PHMC 2015).

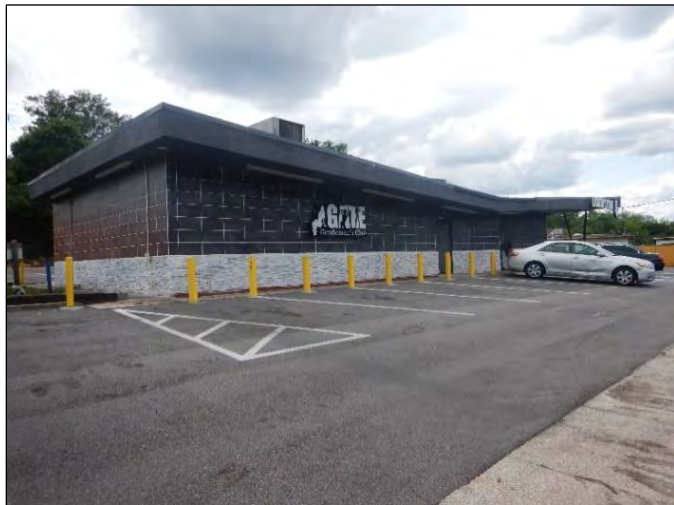
Figure 35. Resource 8DU22981 provides an example of the Mid-Century Modern style within the Trout River Bridge Terrestrial APE. Photograph west.

There are two buildings within the Trout River Bridge Terrestrial APE that can be categorized as Mid-Century Modern (**Figure 35**). The Mid-Century Modern Style rose to popularity from the 1940s through the 1960s. World War II introduced experimental technologies and materials that were used after the war in building new homes for the returning veterans and their families. The increasing popularity of the suburbs created new ideas on healthy living and new design challenges for architecture. Furthermore, an influx of European immigration during the war led to the blending of the earlier Bauhaus movement with that of American architectural traditions (Eng n.d.; Sadowsky n.d.). In response to these stimuli, Mid-Century Modern was characterized by a futuristic aesthetic with an emphasis on function (Richman-Abdou 2017). In an effort to harmonize the exterior natural world with the interior space, large expanses of plate glass and sliding glass doors were employed in design. The style is further characterized by:

- low profile;
- horizontal composition;
- the use of modern materials;
- angular shapes and flat planes;

- open floor plans;
- oversized flared eaves and butterfly roofs;
- changes in elevation;
- lack of reference to earlier styles; and
- natural light (Carney 2018; Eng n.d.; Sadowsky n.d.; Richman-Abdou 2017).

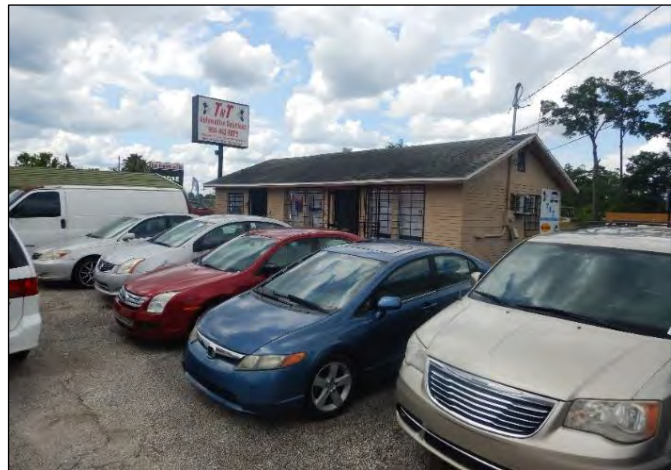
Figure 36. Resource 8DU22982 provides an example of the Minimal Traditional style within the Trout River Bridge Terrestrial APE. Photograph facing northeast.

There are two buildings within the Trout River Bridge Terrestrial APE that can be categorized as Minimal Traditional (**Figure 36**). The Minimal Traditional style grew out of a need for small, simple, economical homes in the United States in the 1930s during the Great Depression. It was a product of the 1934 National Housing Act and the establishment of the Federal Housing Administration (FHA), which was formed to create jobs and improve housing by stimulating the construction industry. Minimal traditional style houses were often built with the assistance of FHA-insured home loans.

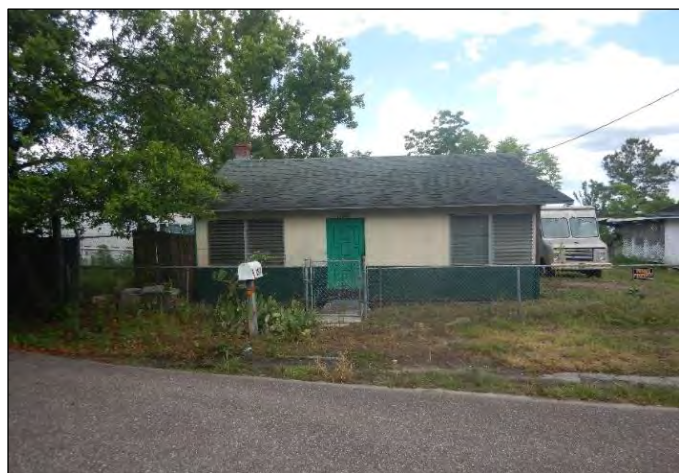
Figure 37. Resource 8DU22975 provides an example of the Frame Vernacular style within the Trout River Bridge Terrestrial APE. Photograph facing northeast.

There are two buildings within the Trout River Bridge Terrestrial APE that can be categorized as Frame Vernacular (**Figure 37**). The Frame Vernacular style

represents those “ordinary” wood frame buildings designed on a basis of local need, material availability, and tradition. The local environment and experience of the builder, often not architecturally trained, provide more influence over the end product than that of most other styles (City of Miami 2017; Glassie 1990). Decoration is often sparse; however, examples of Frame Vernacular may be influenced by a variety of high styles. Characteristics of the Frame Vernacular style often include, but are not limited to:

- Balloon frame;
- Rectangular plan;
- One to two stories;
- Wood siding: weatherboard, drop siding, etc.; and
- Siding may have been replaced with vinyl, aluminum, asbestos shingle, etc. (City of Miami 2017).

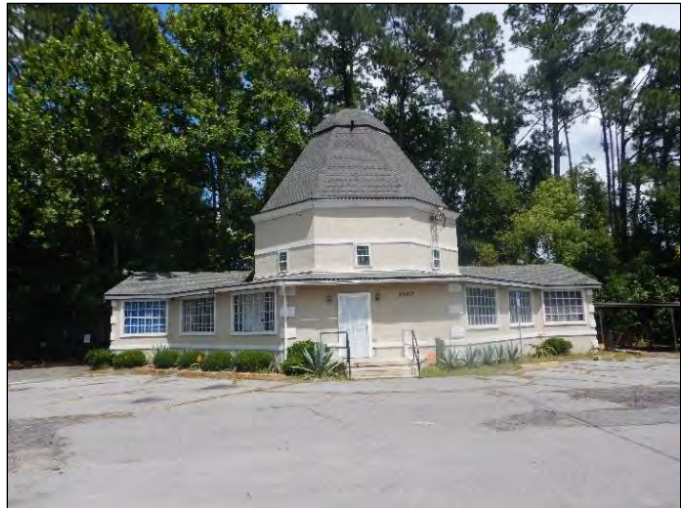
Figure 38. Resource 8DU22986 provides an example of the Eclectic style within the Trout River Bridge Terrestrial APE. Photograph facing northeast.

There is one building within the Trout River Bridge Terrestrial APE that can be categorized as having Eclectic Style elements (**Figure 38**). The twentieth century gave rise to the Eclectic style, which was derived from historic Europeans styles as well as new originally American designs (Stephen F. Austin State University 2013). Eclecticism exists on a spectrum based on how many different styles and elements exist on the building. They are a hybrid of many different styles. A building’s form may contradict many of the elements that adorn the structure. Efficiency as well as new technology influenced this new mix of styles (Antique Home Style, n.d.). New building materials

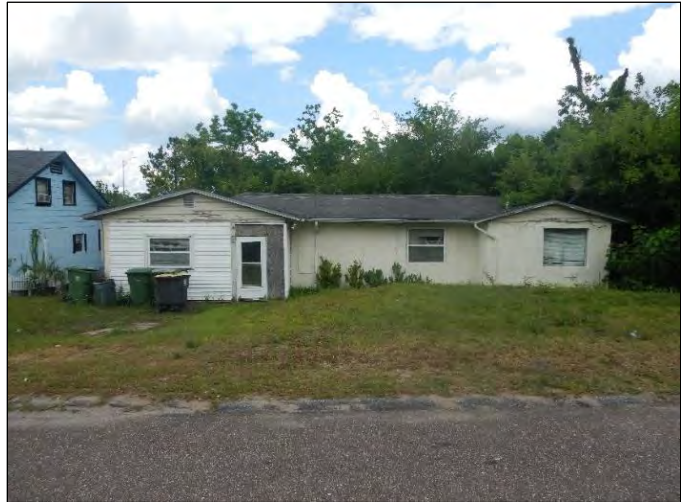
Figure 39. Resource 8DU22978 provides an example of the Masonry Vernacular style within the Trout River Bridge Terrestrial APE. Photograph facing east.

There is one building within the Trout River Bridge Terrestrial APE that can be categorized as Masonry Vernacular (**Figure 39**). Much like the Frame Vernacular style, Masonry Vernacular buildings were designed on a basis of local need, material availability, and tradition. Materials of this style include brick, cement block, oolitic limestone, Ocala block, hollow clay tile, stucco, and stone, amongst others. Decoration is often sparse. However, examples of Masonry Vernacular may be influenced by a variety of high styles. Characteristics of the Masonry Vernacular style vary widely based on location, need, and experience. The style is further characterized by:

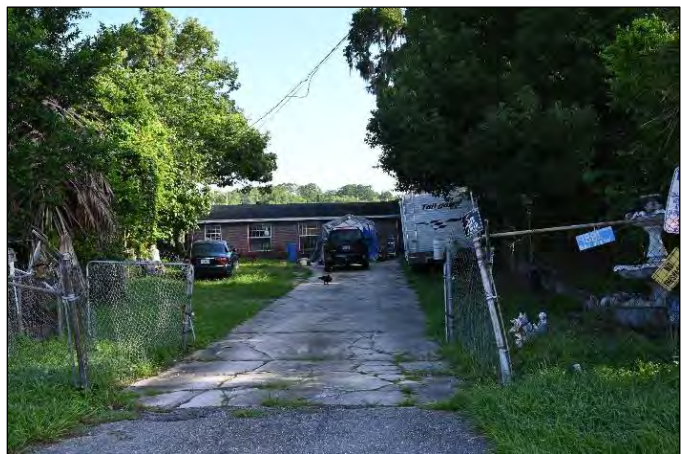
Figure 40. Resource 8DU22985 provides an example of the Ranch style within the Trout River Bridge Terrestrial APE. Photograph facing north.

There is one building within the Trout River Bridge Terrestrial APE that can be categorized as Ranch style (**Figure 40**). The evolution of the Ranch style had multiple centers: the Chicago area, inspired by the Prairie Houses of Frank Lloyd Wright; the American southwest, the vestiges of working ranches providing inspiration; and California, where rapid growth in the

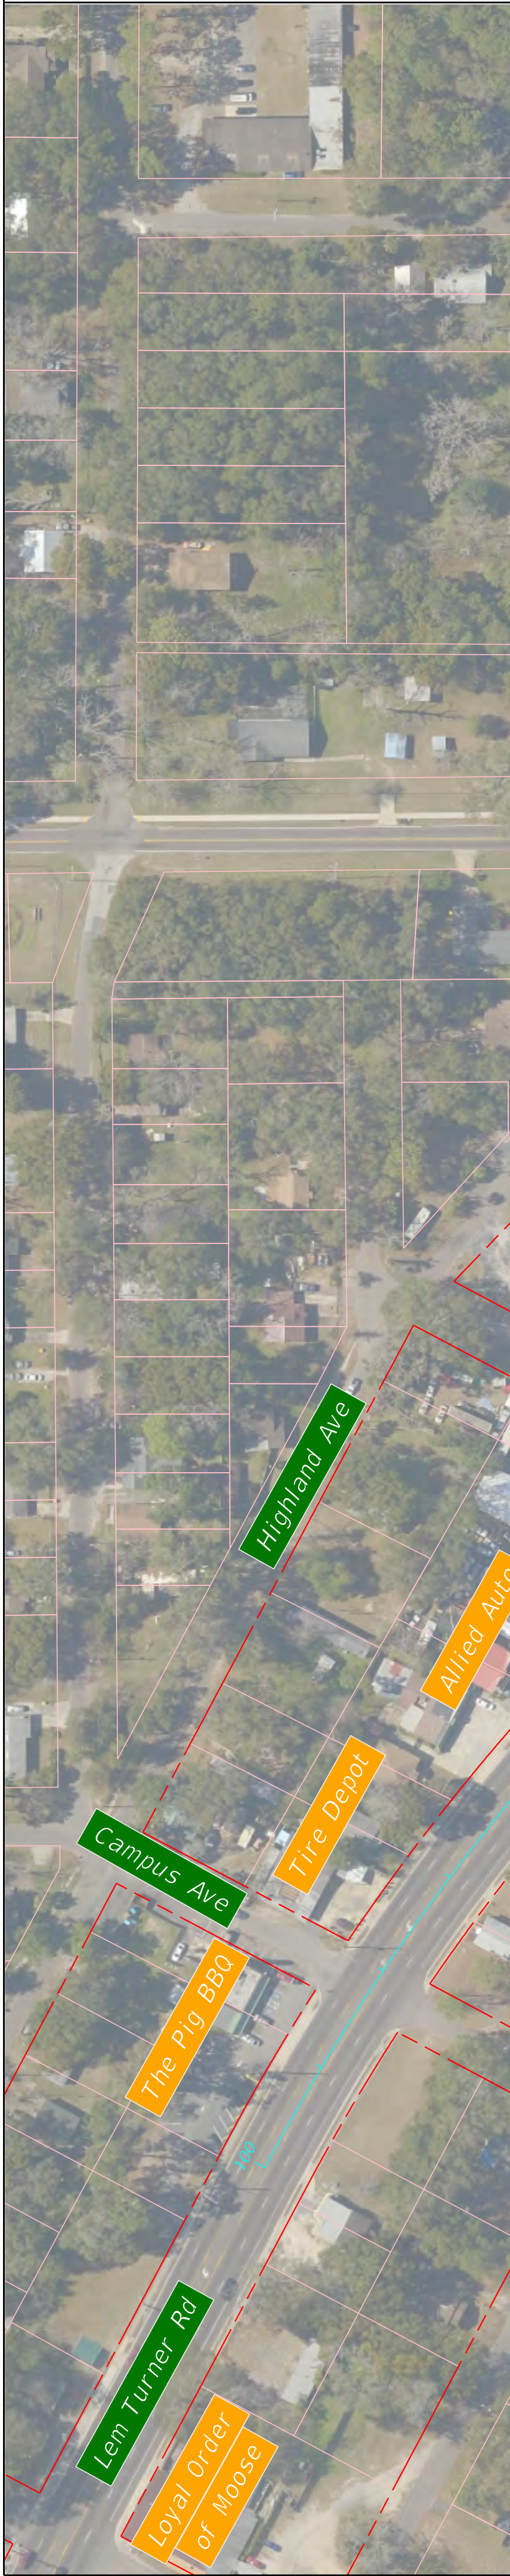
Alt H Mod 3

TYPICAL ALTERNATIVE 5
BRIDGE #720033
SR 115 (LEM TURNER RD) OVER TROUT RIVER
DESIGN SPEED = 45 MPH

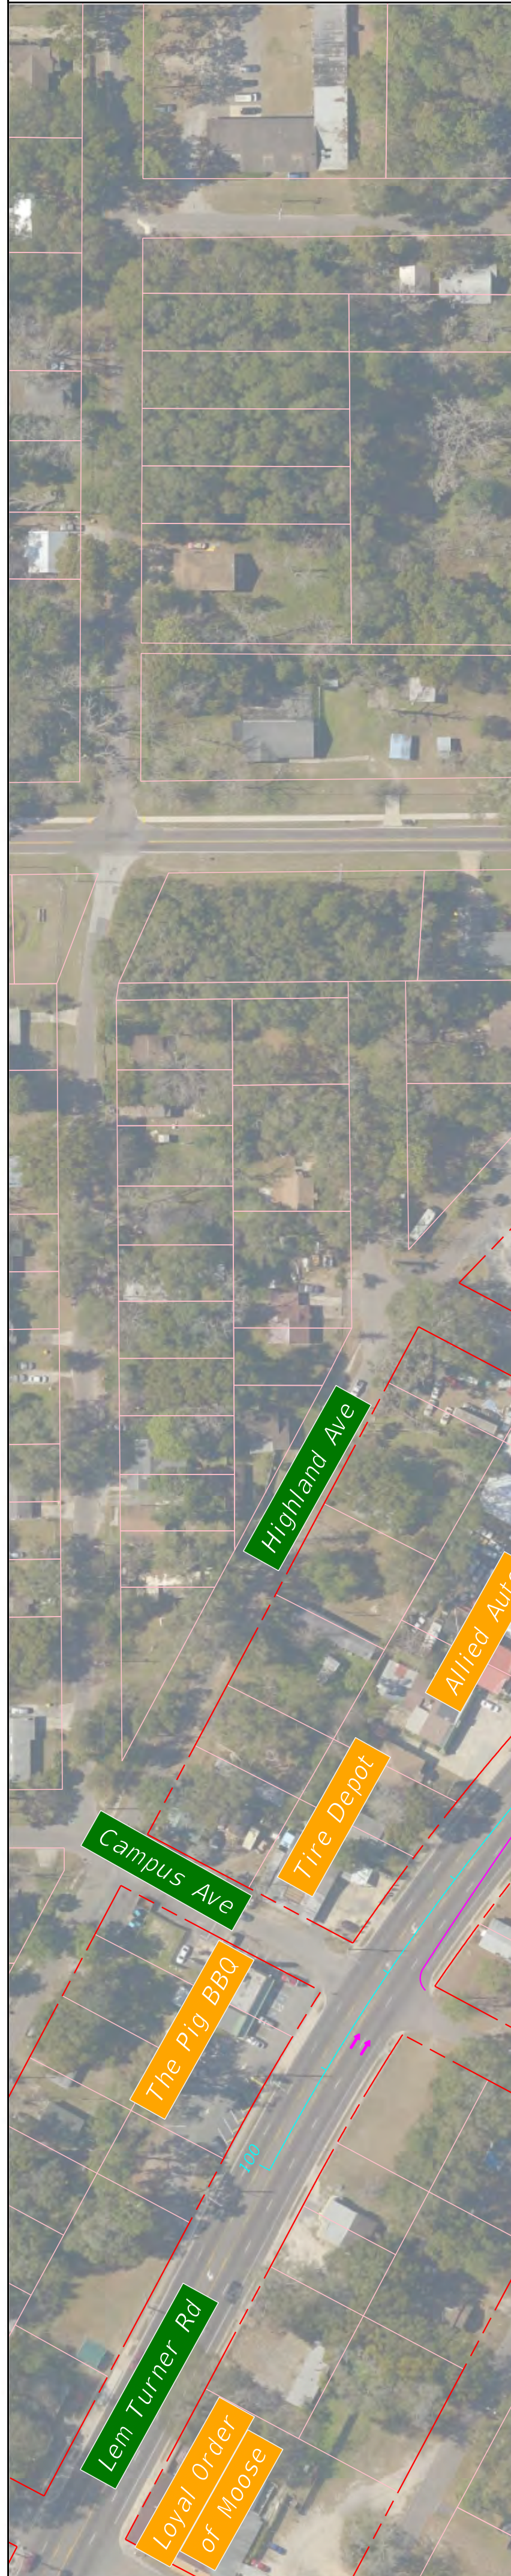
TTCP Alt H MOD 3 Phase 2

TYPICAL ALTERNATIVE 5
BRIDGE #720033
SR 115 (LEM TURNER RD) OVER TROUT RIVER
DESIGN SPEED = 45 MPH

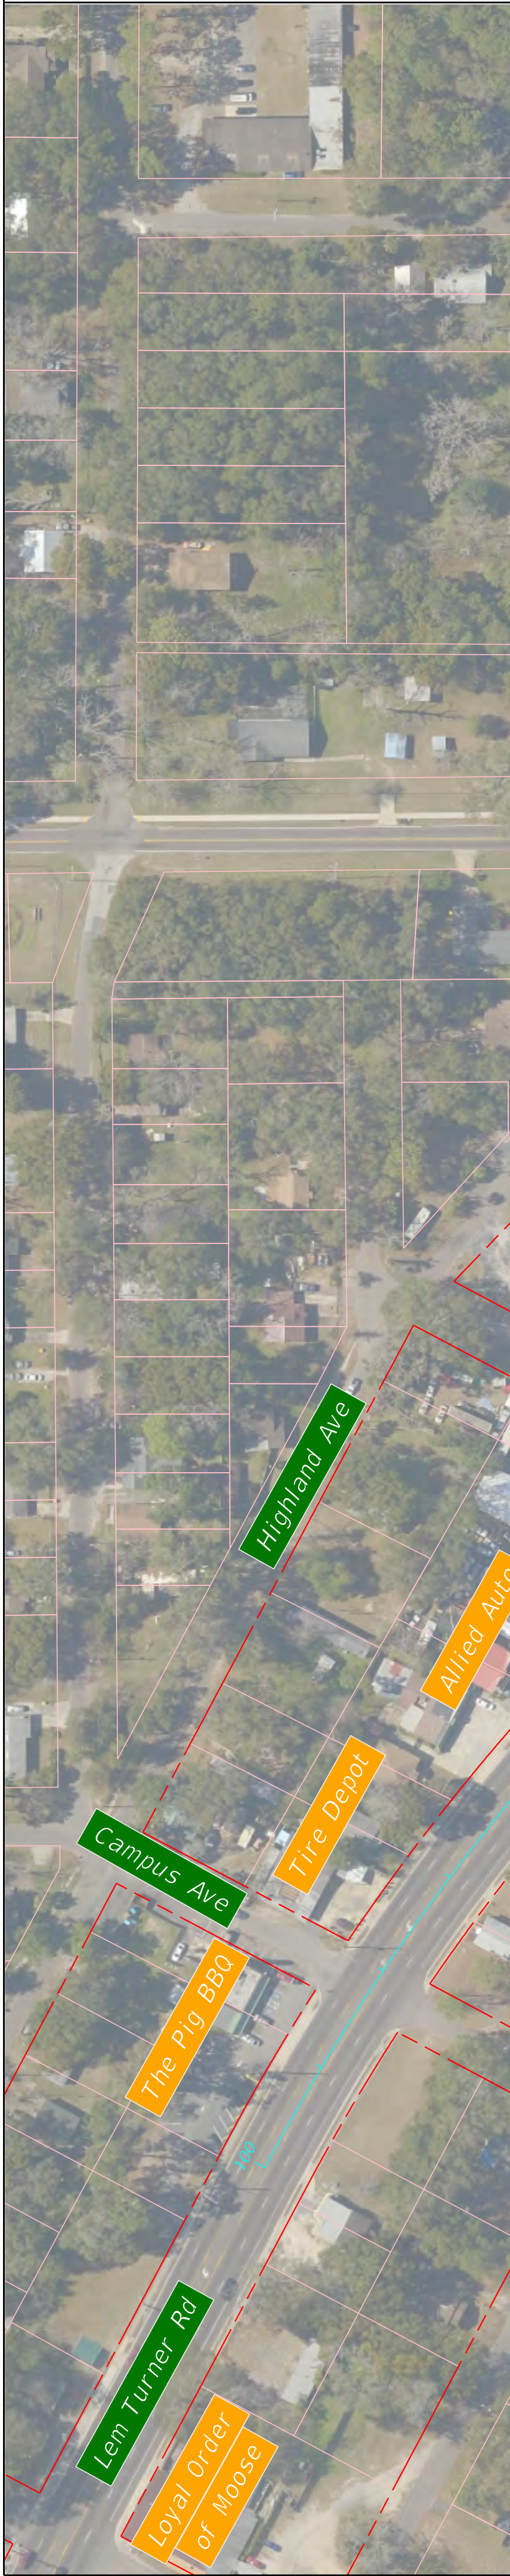
Alt H Mod 2

TYPICAL ALTERNATIVE 5
BRIDGE #720033
SR 115 (LEM TURNER RD) OVER TROUT RIVER
DESIGN SPEED = 45 MPH

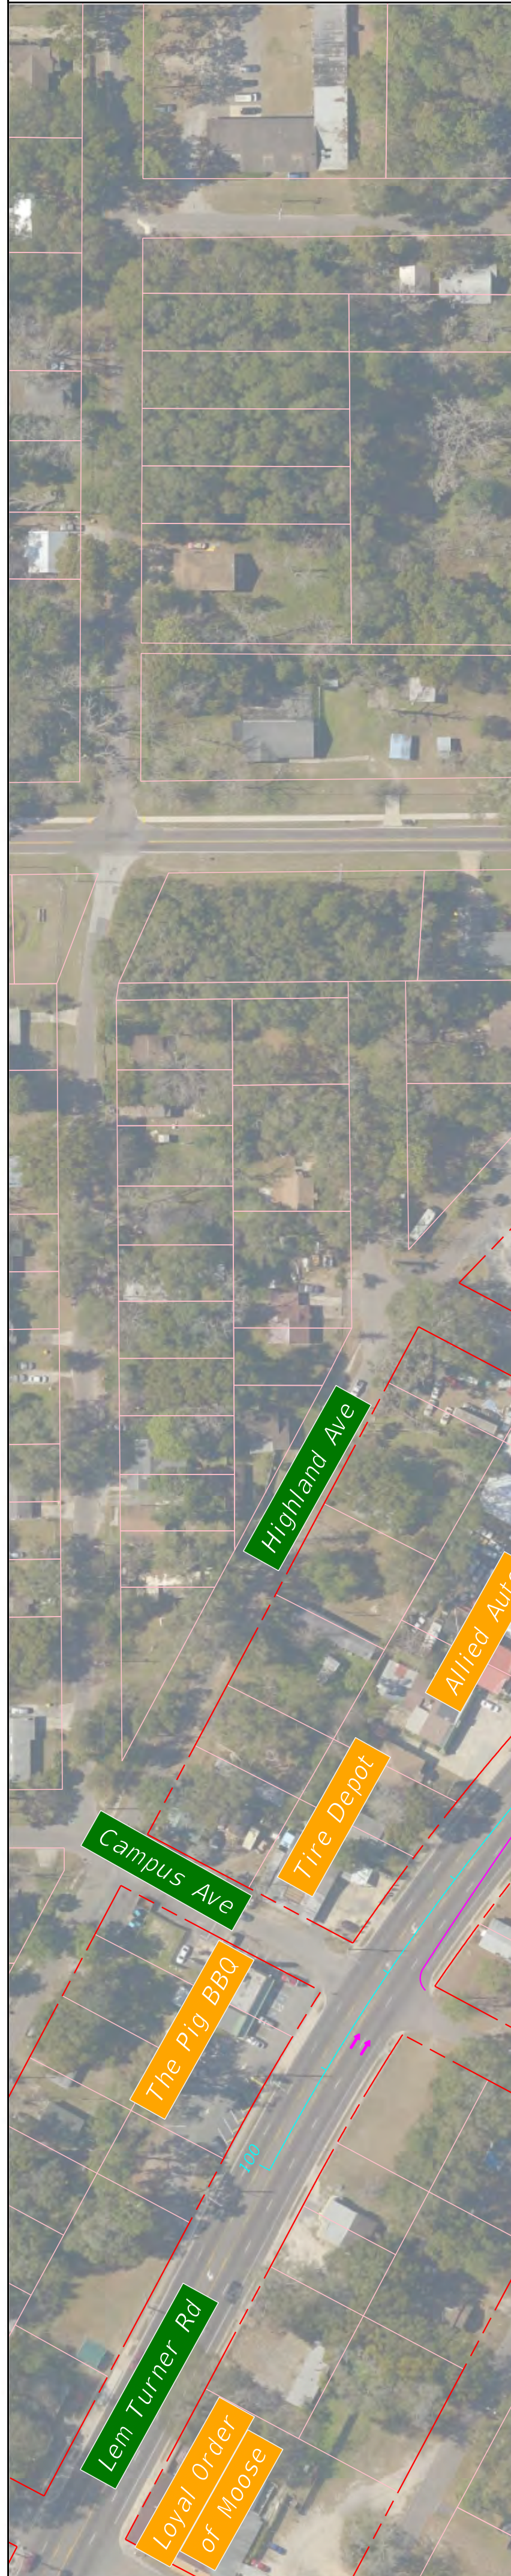
TTCP Alt H MOD 2 Phase 2

TYPICAL ALTERNATIVE 5
BRIDGE #720033
SR 115 (LEM TURNER RD) OVER TROUT RIVER
DESIGN SPEED = 45 MPH

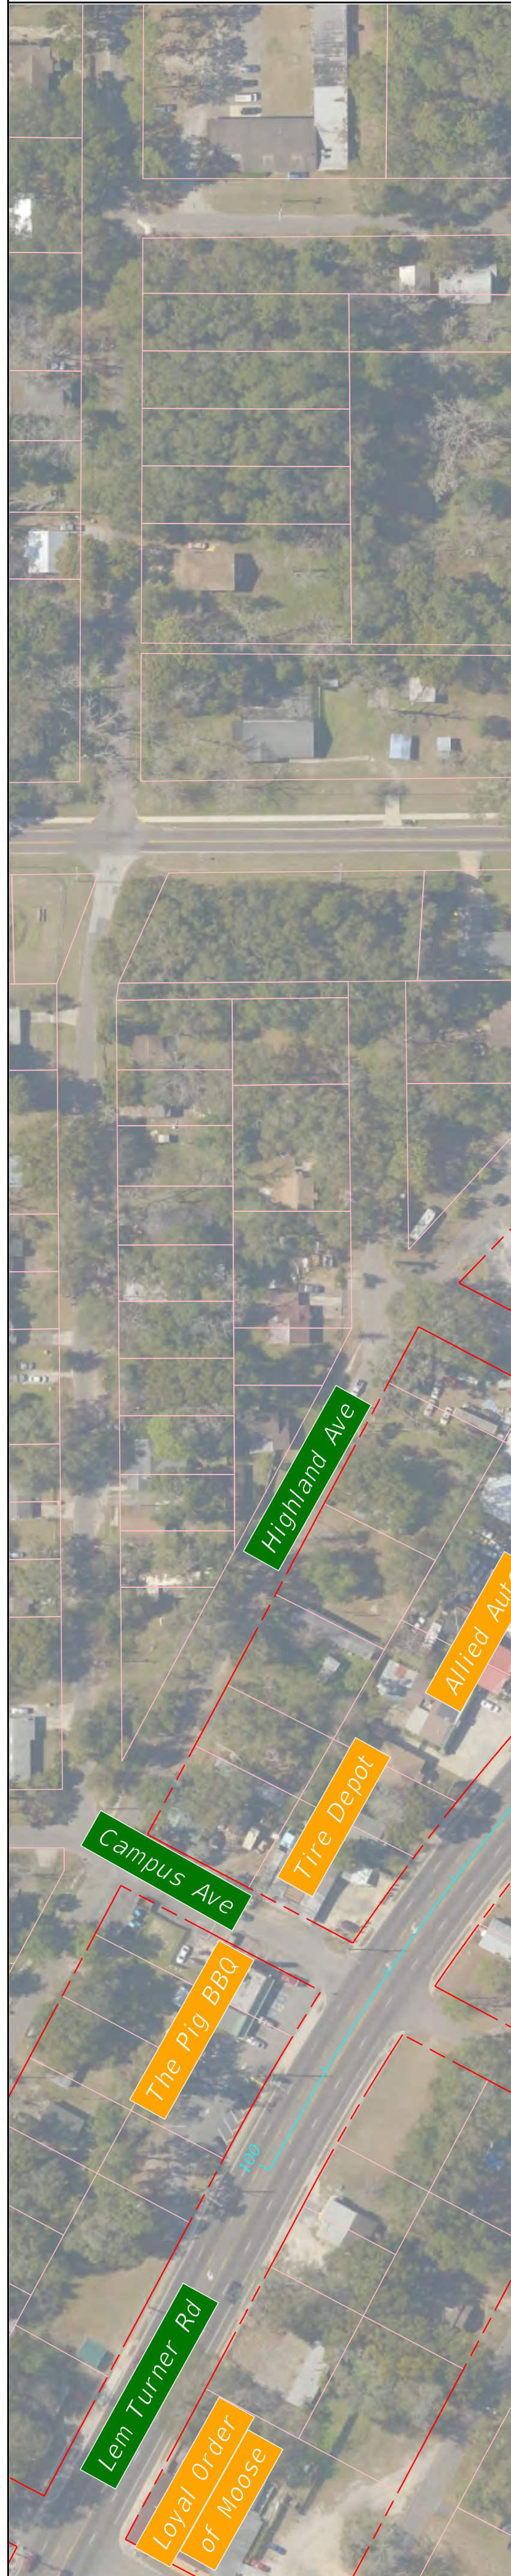
TTCP Alt H MOD 2 Phase 3

TYPICAL ALTERNATIVE 5
BRIDGE #720033
SR 115 (LEM TURNER RD) OVER TROUT RIVER
DESIGN SPEED = 45 MPH

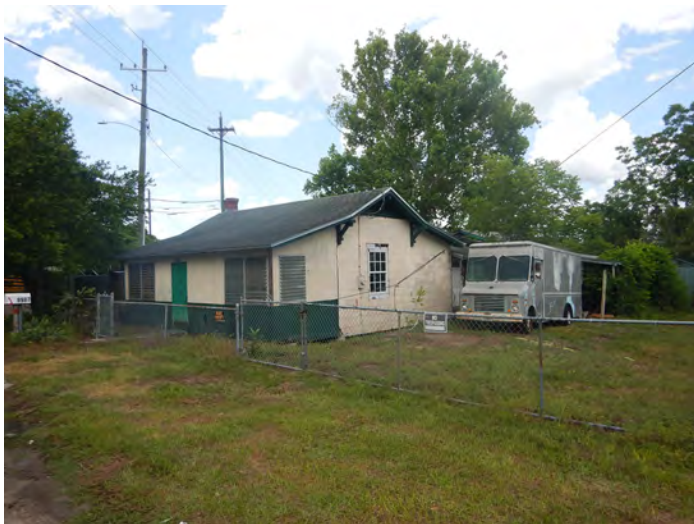
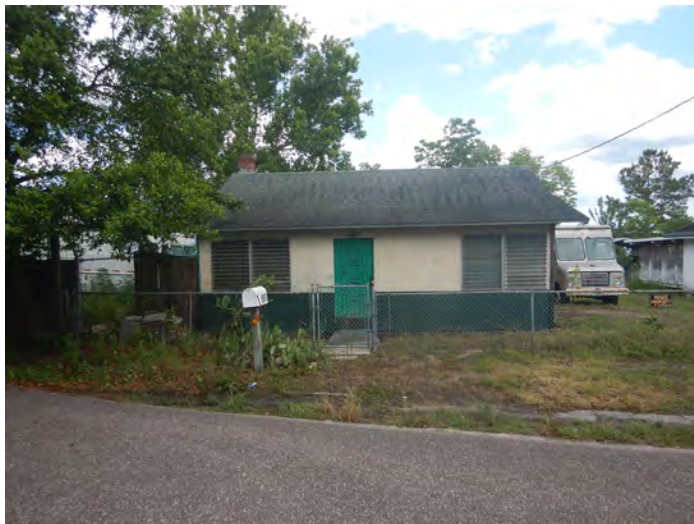
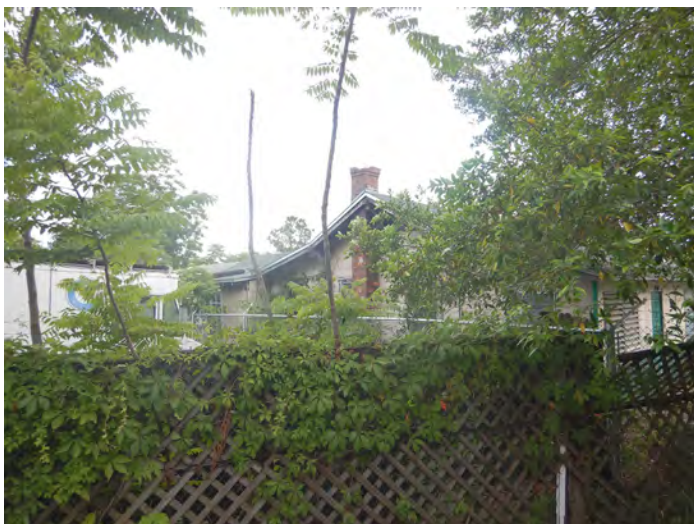
8DU22975_a Facing North

8DU22975_b Facing Northeast

8DU22975_c Southeast

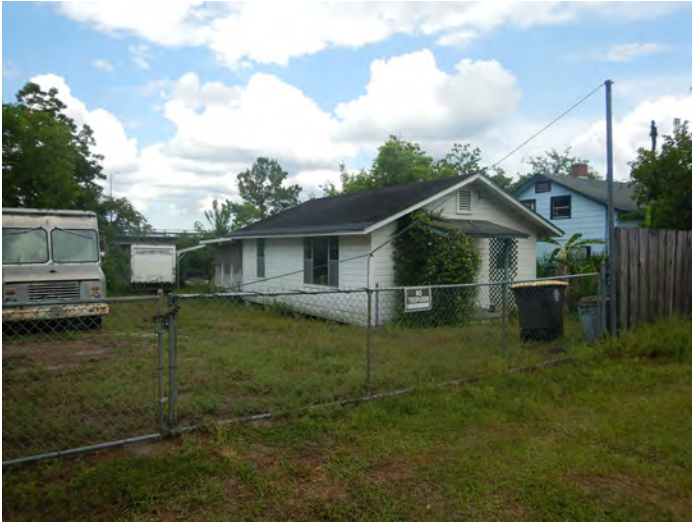
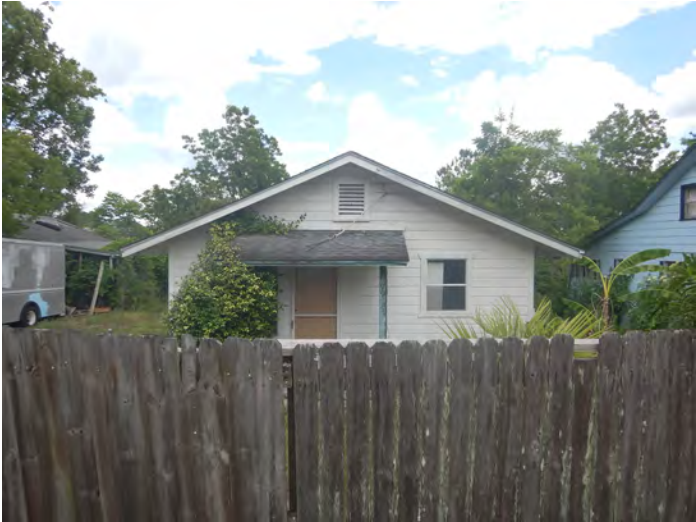
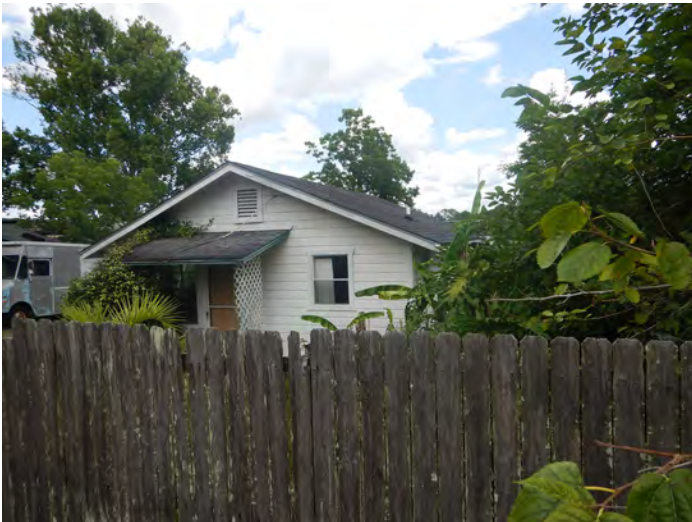
8DU22976_a Facing Southeast

8DU22976_b Facing Northeast

8DU22976_c Facing North
