Cultural Resource Assessment Survey

Lem Turner Road (State Road 115) over Trout River Bridge Replacement, Duval County, Florida

Financial Management (FM) No. 437437-2
Federal Aid Project ID No. TBD

July 2021

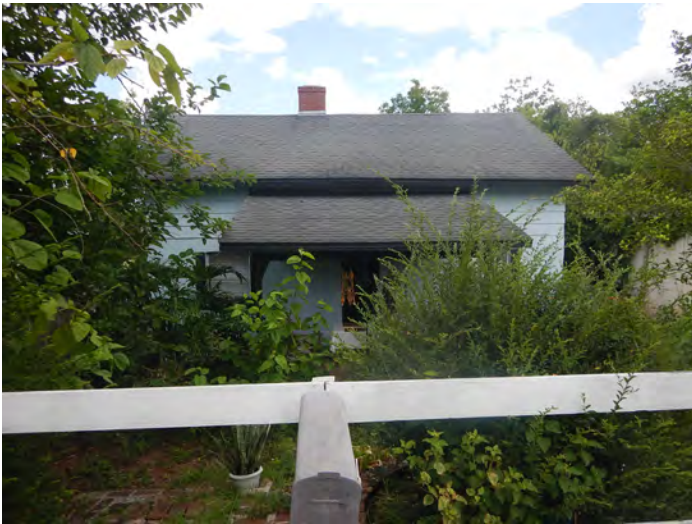
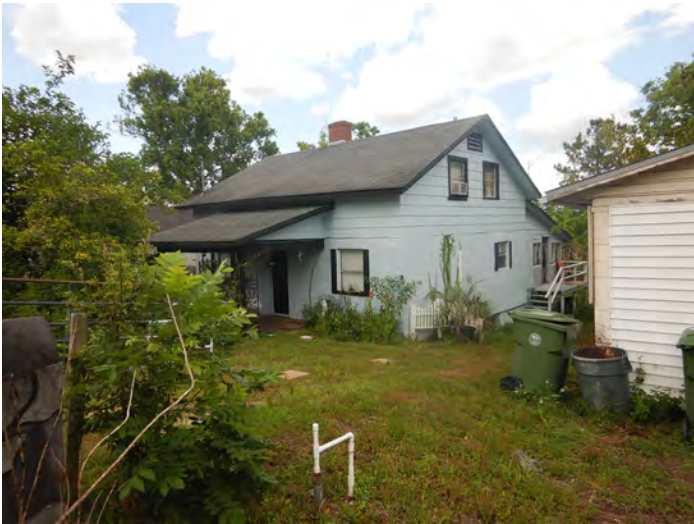
8DU22977_a Facing Northeast

8DU22977_b Facing North

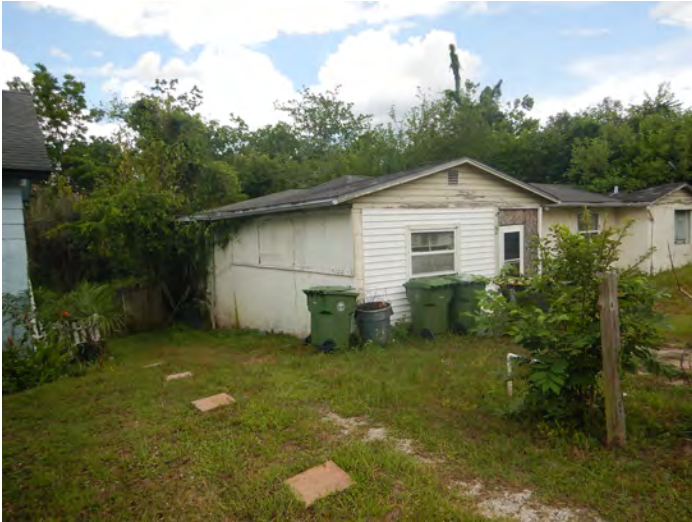
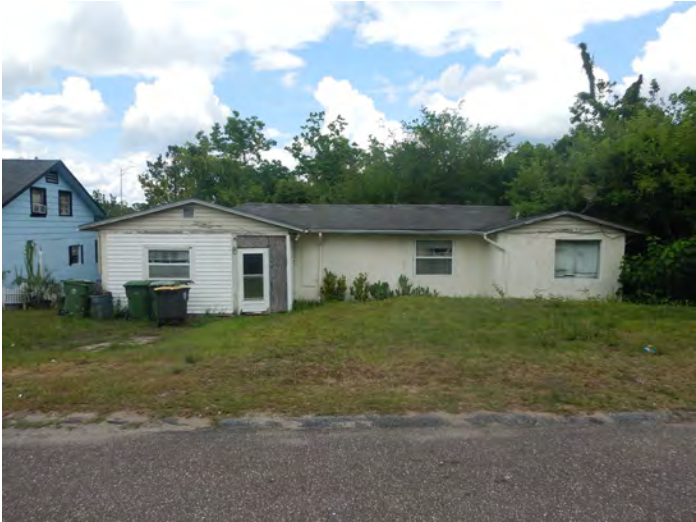
8DU22978_a Facing Southeast

8DU22978_b Facing East

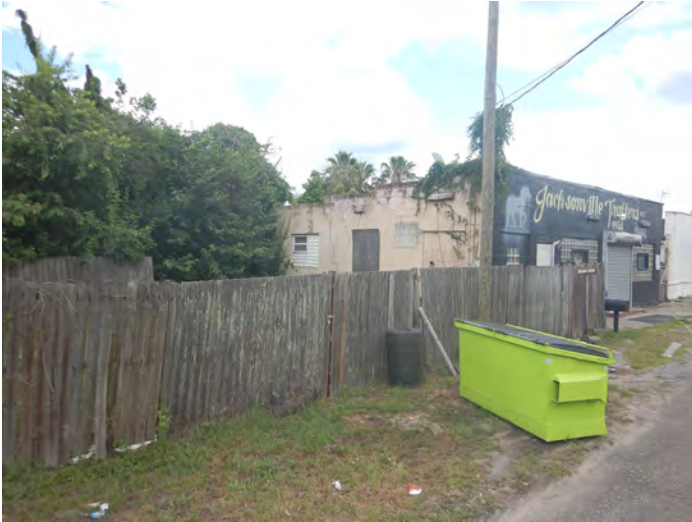
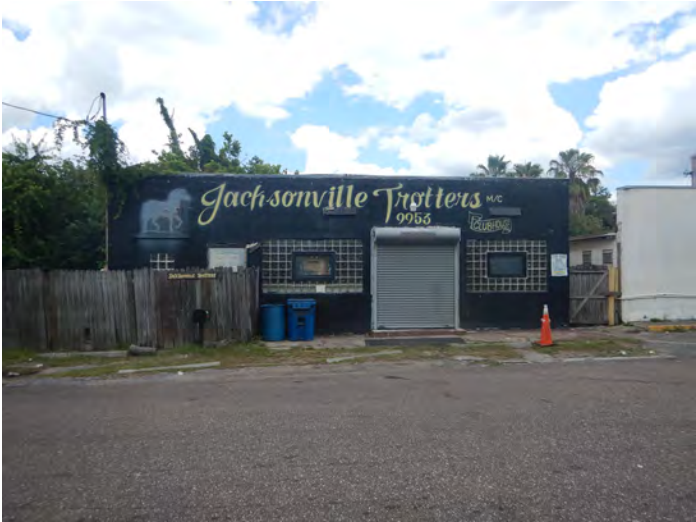
8DU22979_a Facing Southeast

8DU22979_b Facing Northeast

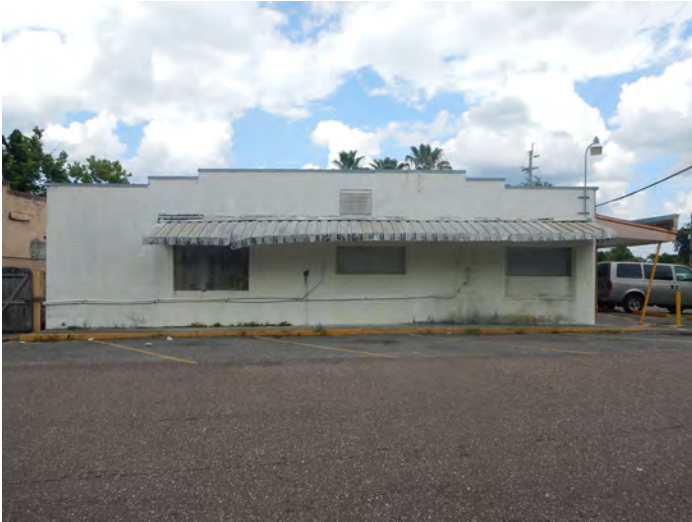
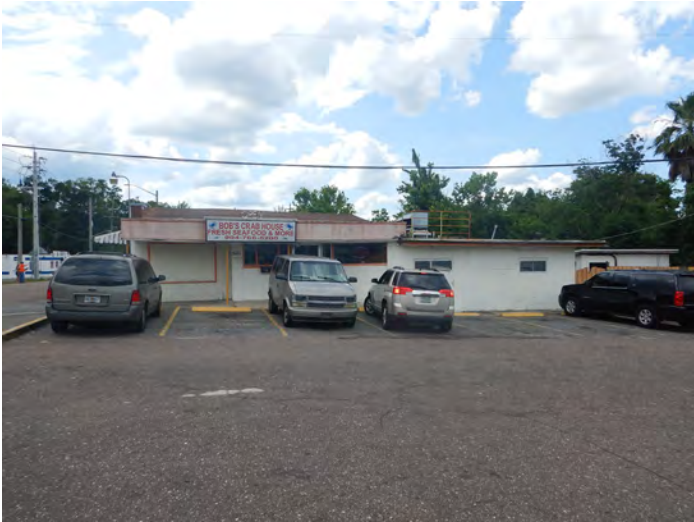
8DU22980_a Facing Northeast

8DU22980_b Facing Northwest

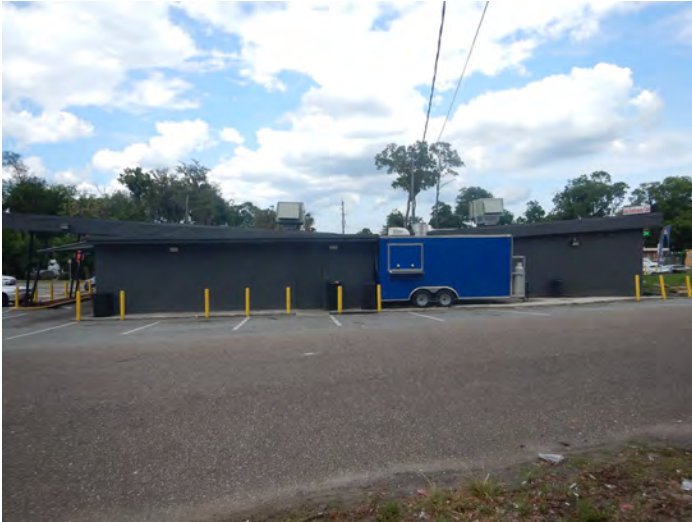
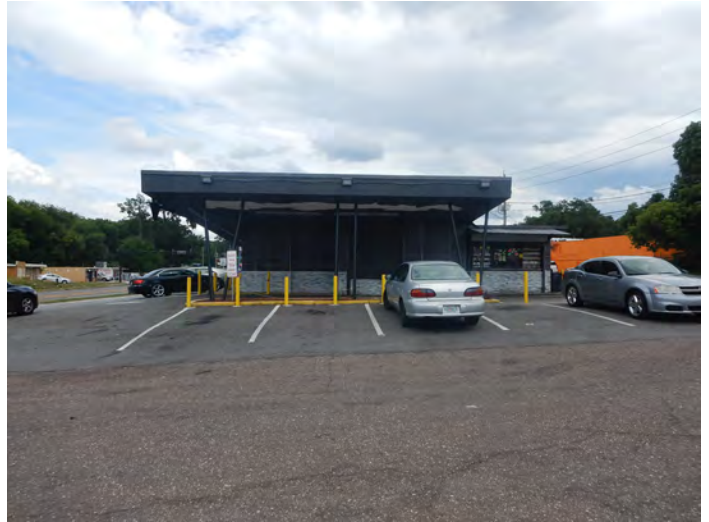
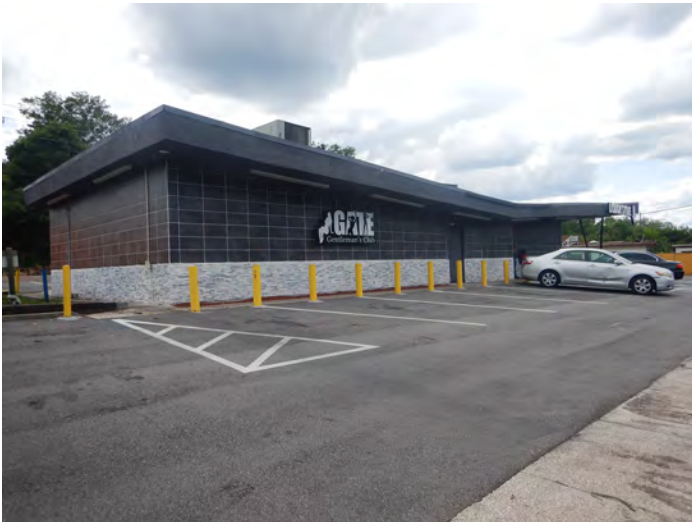
8DU22981_a Facing Northeast

8DU22981_b Facing Southeast

8DU22981_c Facing West

Resource 8DU22981 is a 1 story, masonry-vernacular residence with a rectangular plan set on grade on concrete slab foundation. Asphalt shingle covers the gable on hip roof, and vinyl and stucco clads the masonry walls with wood siding in gable ends.

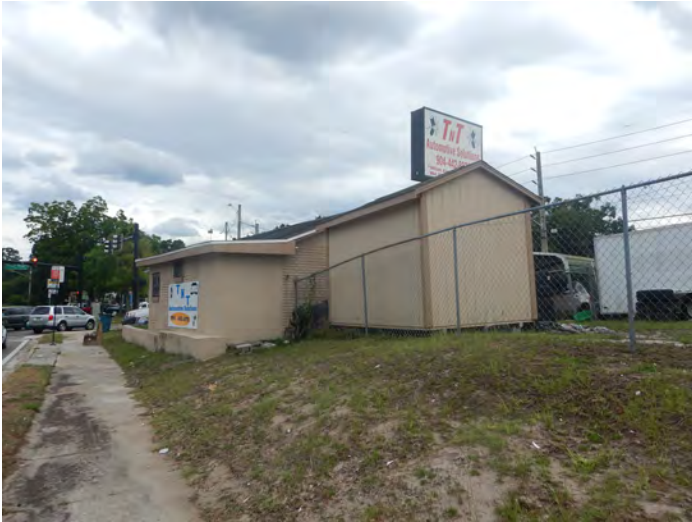
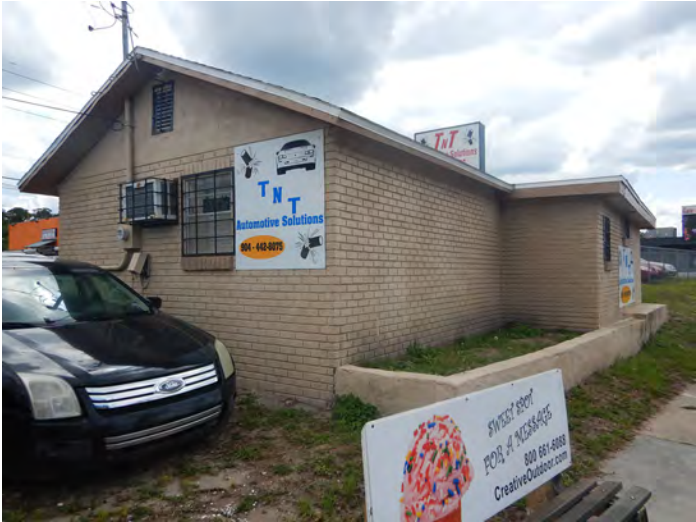
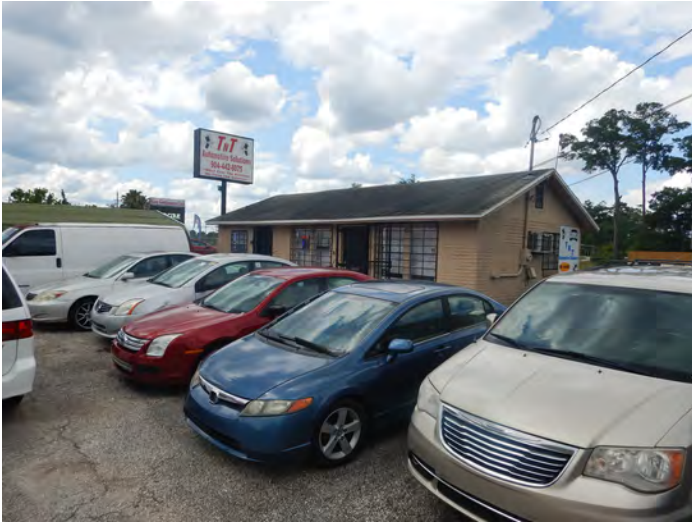
No porch observedCondition (overall resource condition): ☐ excellent ☒ good ☐ fair ☐ deteriorated ☐ ruinous

Resource 8DU22982 is a 1 story, commercial auto repair shop with a square plan set on grade on concrete slab foundation. Built-up/T&G covers the flat roof, and paint adorns the masonry walls. Glass block windows with fixed windows inset.Archaeological Remains _____ ☐ Check if Archaeological Form Completed

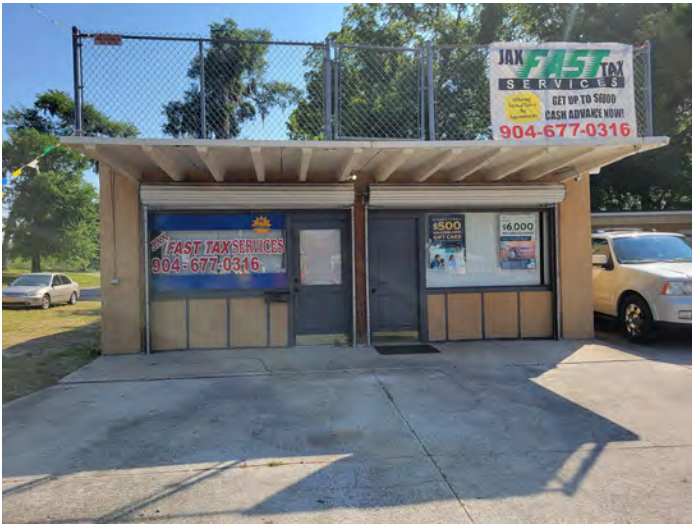
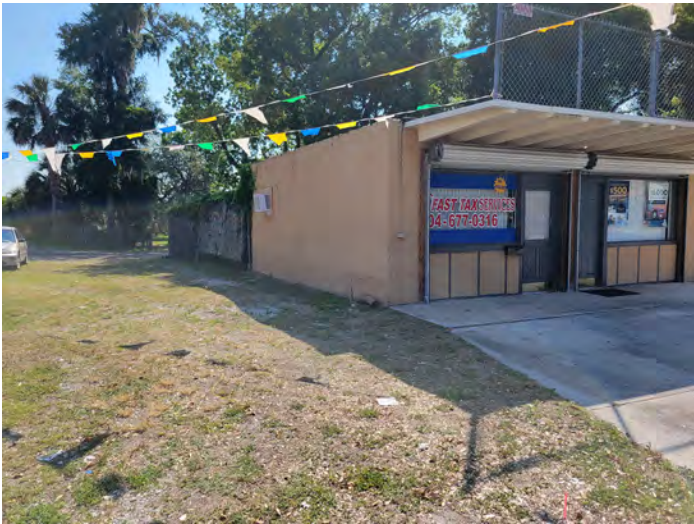
Condition (overall resource condition): ☐ excellent ☐ good ☒ fair ☐ deteriorated ☐ ruinous

Resource 8DU22983 is a 1 story, commercial restaurant with a square plan set on grade on concrete slab foundation. Composition roll covers the flat and gable roof, and vertical planks clad the masonry walls. Flat extension with prominent fascia board.

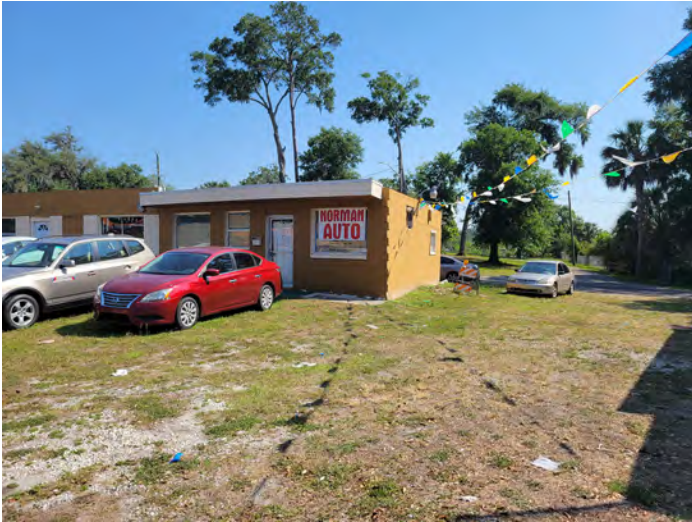
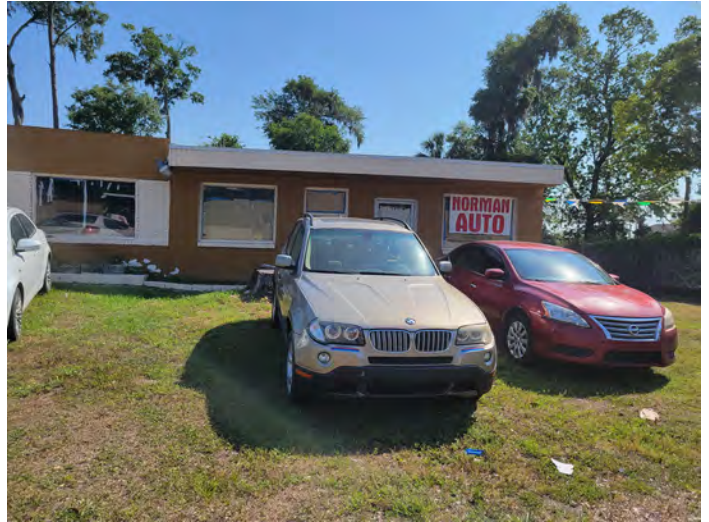
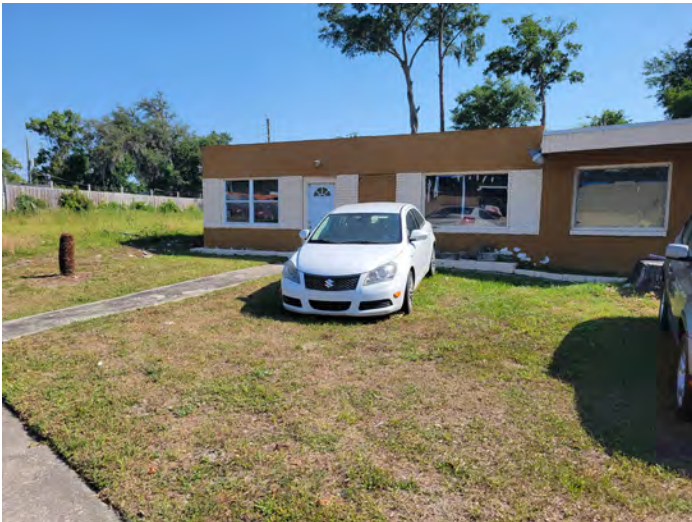
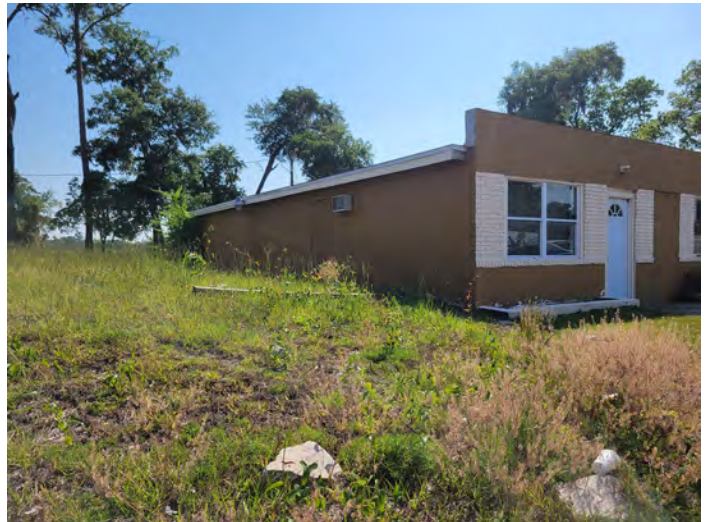
Condition (overall resource condition): ☐ excellent ☒ good ☐ fair ☐ deteriorated ☐ ruinous

Resource 8DU22984 is a 1 story, mid-century modern bar with a rectangular plan set on grade on slab concrete foundation. Built up/T&G covers the butterfly roof and flat roof addition Tile and art stone clad the walls. Integrated carport on N façade.

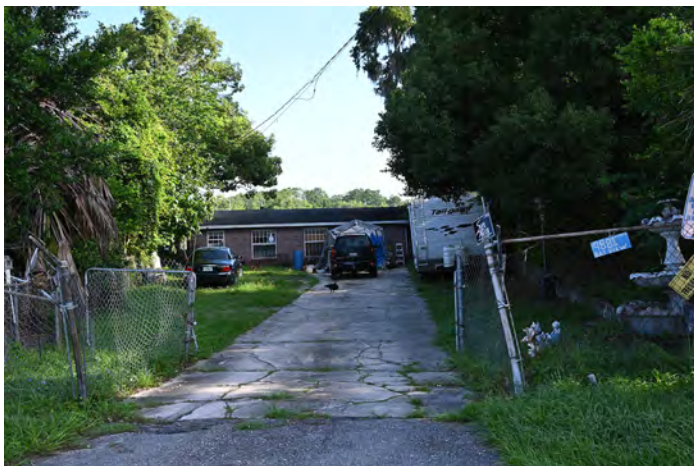
8DU22985_a Facing North

Condition (overall resource condition): ☐ excellent ☒ good ☐ fair ☐ deteriorated ☐ ruinous

Resource 8DU22985 is a 1 story, minimal traditional auto dealership with a rectangular plan set on obscured foundation. Asphalt shingle covers the side-gable roof, and brick veneer and stucco clads the walls. Stuccoed planters on W façade.
