**CULTURAL RESOURCE ASSESSMENT SURVEY ADDENDUM
FOR THE SR 115 (LEM TURNER ROAD) OVER TROUT RIVER BRIDGE
REPLACEMENT PROJECT DEVELOPMENT & ENVIRONMENT STUDY
DUVAL COUNTY, FLORIDA**

**FINANCIAL MANAGEMENT NO. 437437-2
SEARCH PROJECT NO. 21051**

**FLORIDA DEPARTMENT OF TRANSPORTATION, DISTRICT 2
LAKE CITY, FLORIDA**

AUGUST 2023

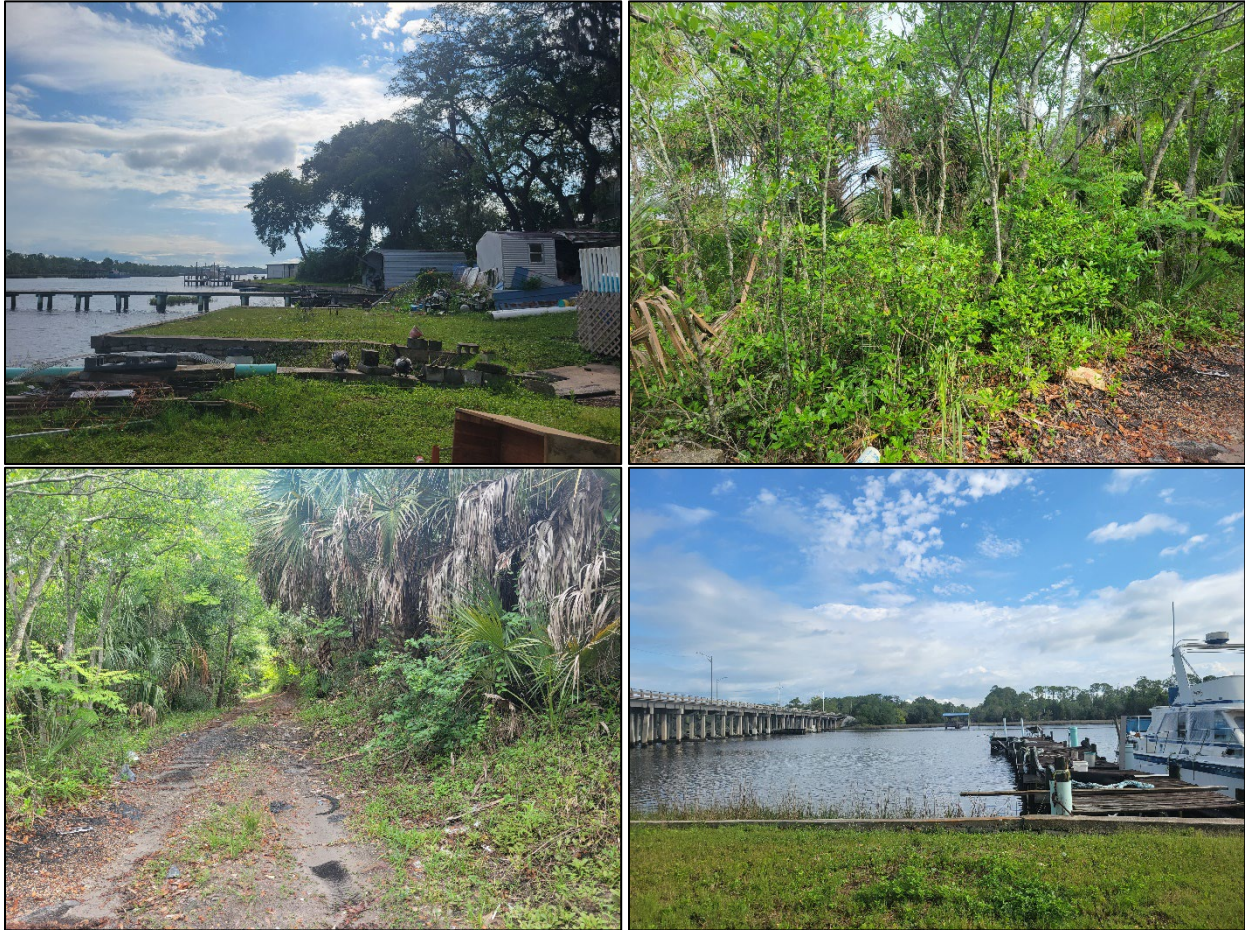
Figure 6. Representative views of the APE. Top left: North end of the Pond 1 footprint showing disturbances, view east. Top right: Pond 2 footprint showing slope leading to marsh, view northwest. Bottom left: Two-track road within Pond 2 footprint, view south. Bottom right: North end of Pond 1 footprint showing historic dock.

Proposed Pond 1 consists of an 0.21 ac footprint on a residential parcel along the south bank of the Trout River. Modern conditions of the proposed pond location consist of a residential building with existing pavement, buried utilities, and a modified landscape (**Figure 6**). Archaeological testing within Pond 1 consisted of the excavation of one shovel test, negative for any artifacts. Additionally, the pond footprint was pedestrian-surveyed in locations where modern conditions (such as pavement, utilities, drainage structures) precluded subsurface testing.

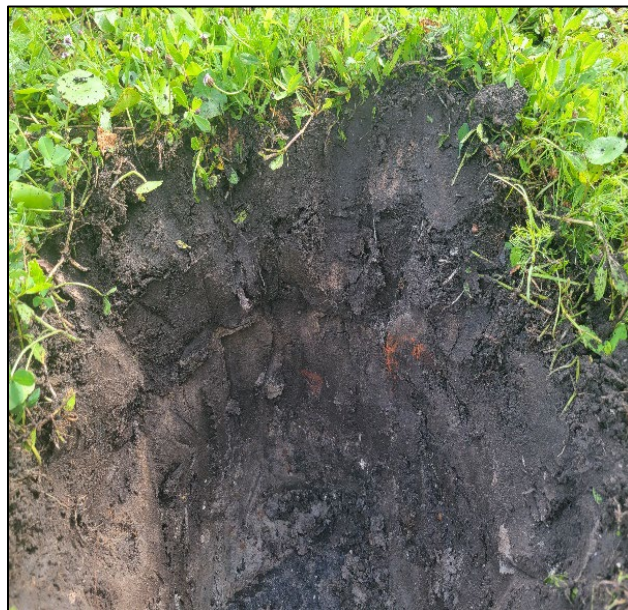
One shovel test was excavated in the northwest portion of the Pond 1 footprint. The soil profile displayed by the test consisted of a very dark grayish brown (10YR 3/2) loamy sand from 0 to 40 cmbs (0 to 15.8 inbs), over a light gray (10YR 7/2) sand from 40 to 50 cmbs (15.8 to 19.7 inbs), terminating at 50 cmbs (19.7 inbs) due to inundation and heavy disturbance (**Figure 7**). Soils within the shovel test were heavily disturbed with mottling throughout. Modern brick, glass, and shell inclusions were present in both strata. No artifacts, archaeological features, or archaeological sites were identified during the survey.

Figure 7. Shovel test profile in the Pond 1 footprint.

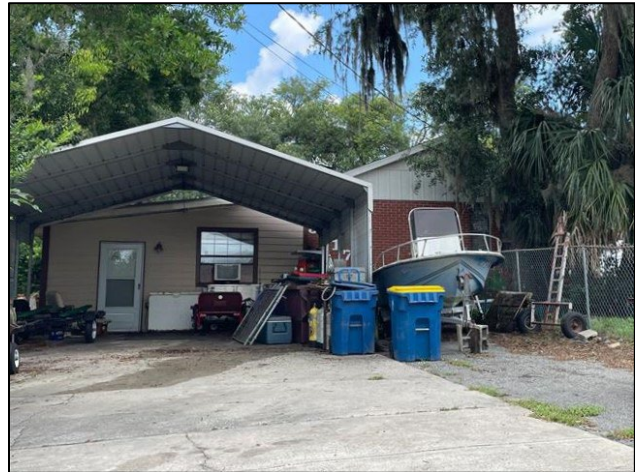
Resource 8DU23534, 9917 Bayview Avenue, is a newly recorded resource within Duval County (see **Figure 8**). It is in Section 15 of Township 1 South, Range 26 East as shown on the 2021 *Jacksonville, Fla.* USGS quadrangle map. The building is on a rectangular parcel, bounded to the east and west by private parcels, the south by Bayview Avenue, and the north by Trout River. The circa (ca). 1977 residence is a one-story, irregular-plan Masonry Vernacular style building (**Figure 9**). The front gable roof of the main block is flanked by a shed roof addition on the west façade visible from the street. The windows consist of various frame and light configurations, including two-over-two metal windows, eight-over-eight vinyl window, one-over-one vinyl windows, and vertical rectangular casement windows in a grouping of four. Along with the addition on the west façade, the residence has an enclosed porch on the north façade, two metal carports, a wooden deck, a dock, and a covered boat area.

Figure 9. Resource 8DU23534, facing North.

Based on the field survey and further research, it is the opinion of SEARCH that Resource 8DU23534 (9917 Bayview Avenue) is not significant under Criterion A as it is not indicative of a

particular era and is not associated with any significant period, event, or theme. Furthermore, the resource is not significant under Criterion B because it lacks association with any person(s) significant in history. Resource 8DU23534 is not significant under Criterion C as it is not a rare or excellent example of an architectural style. The resource is a common Masonry Vernacular residence with no architectural distinction. Finally, 8DU23534 is not significant under Criterion D because it lacks the potential to yield further information of historical importance. Therefore, it is the opinion of SEARCH that 8DU23534 is not eligible for listing in the NRHP, either individually or as a contributor to a historic district.

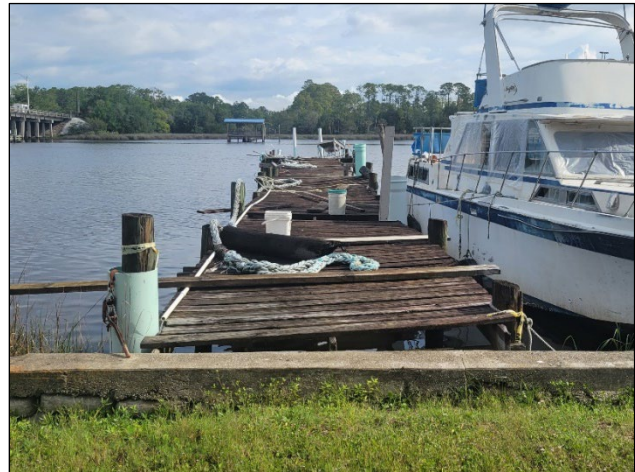
The wood dock is 135 ft long and 7 ft wide. Resource 8DU23535 consists of circular wood posts set into the riverbed with opposing posts connected by beams and supporting joists beneath the deck boards. A few posts are

Figure 10. Resource 8DU23535 facing north.

jacketed with plastic bumpers. The overall condition of the 8DU23535 is poor with obvious signs of deterioration.

Based on the field survey and further research, it is the opinion of SEARCH that Resource 8DU23535 (9881 Bayview Avenue Dock) is not significant under Criterion A as it is not indicative of a particular era and is not associated with any significant period, event, or theme. Furthermore, the resource is not significant under Criterion B because it lacks association with any person(s) significant in history. Resource 8DU23535 is not significant under Criterion C as it is not a unique or excellent example of an architectural style. The resource is a common wood dock with no marine engineering or architectural distinction. Finally, 8DU23535 is not significant under Criterion D because it lacks the potential to yield further information of historical importance. Therefore, it is the opinion of SEARCH that 8DU23535 is not eligible for listing in the NRHP, either individually or as a contributor to a historic district.

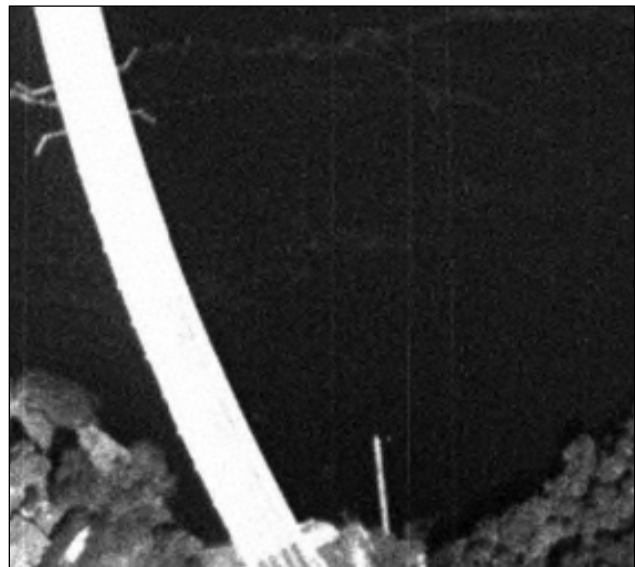
The ca. 1959 wood dock, 8DU23535, is visible on a historic aerial photograph from 1959 and may have been built to assist with the construction of the adjacent SR 115 Bridge over the Trout River (FDOT Bridge No. 720033), which was built in 1957 (**Figure 11**). This bridge is also discussed in the 2021 corridor survey (FMSF Survey No. 28035; Lent et al. 2021); however, it was not evaluated during that survey as it met the requirements for the 2012 *Program Comment Issued for Streamlining Section 106 Review for Actions Affecting Post-1945 Concrete and Steel Bridges* (FR 2012:68,793–687,95) as discussed in the architectural field methods sections.

Figure 11. Historic aerial photograph of Resource 8DU23535. Source: FDOT 1959.
