## **APPENDIX C**

### **ENVIRONMENTAL DATABASE REPORT**

**SR 16 From IGP To I-95**

September 29, 2023

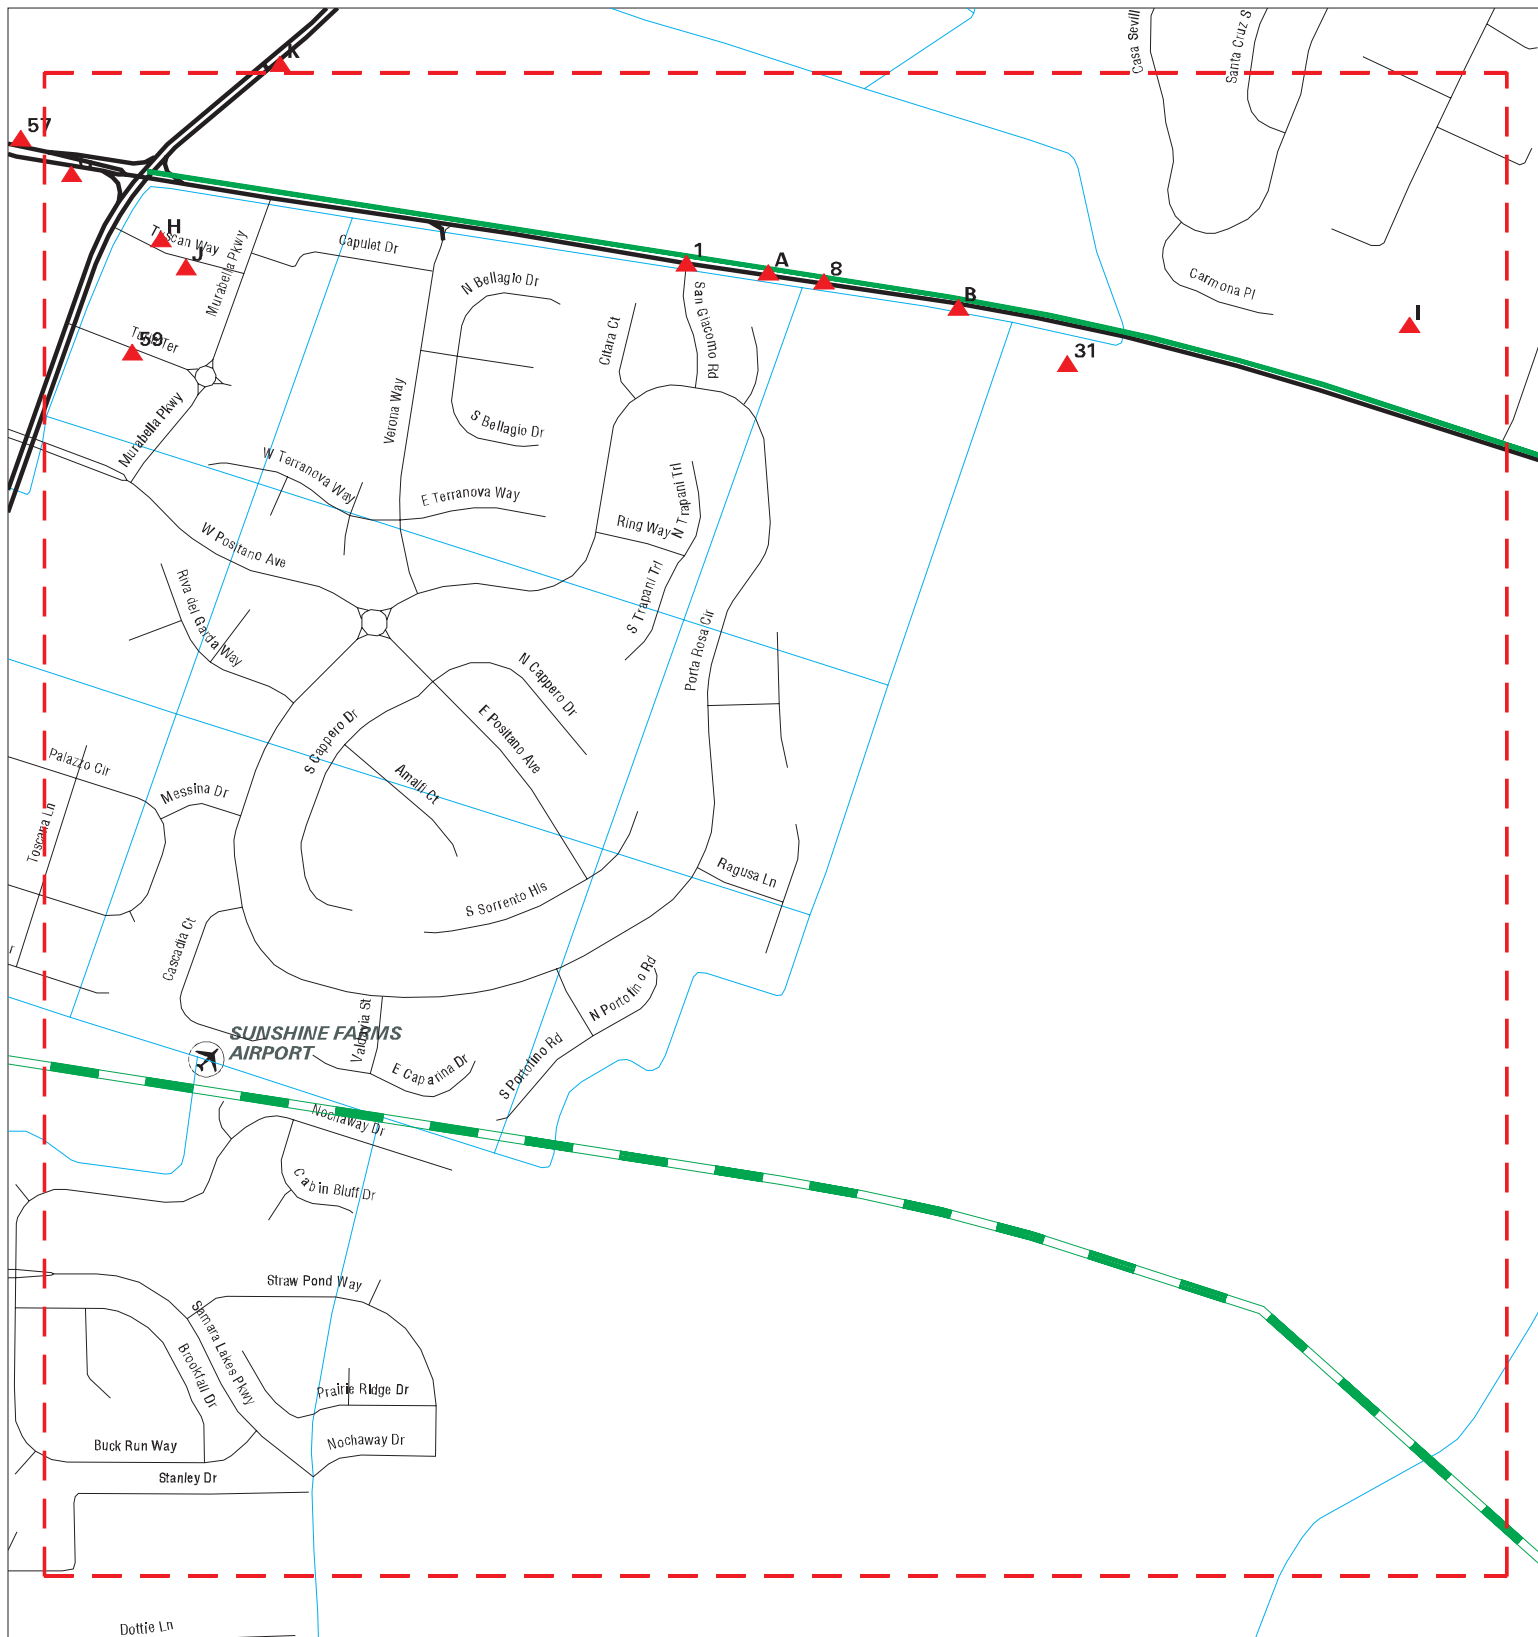
## Focus Map - 5 - 7458221.5s

| MAP ID /<br>FOCUS MAP | SITE NAME | ADDRESS | DATABASE ACRONYMS | DIST (ft. & mi.)<br>DIRECTION |
|---|---|---|---|---|
| 57 / 4 | WALGREEN'S | 5440 SR 16 | HAZ WASTE | 771 0.146 WNW |

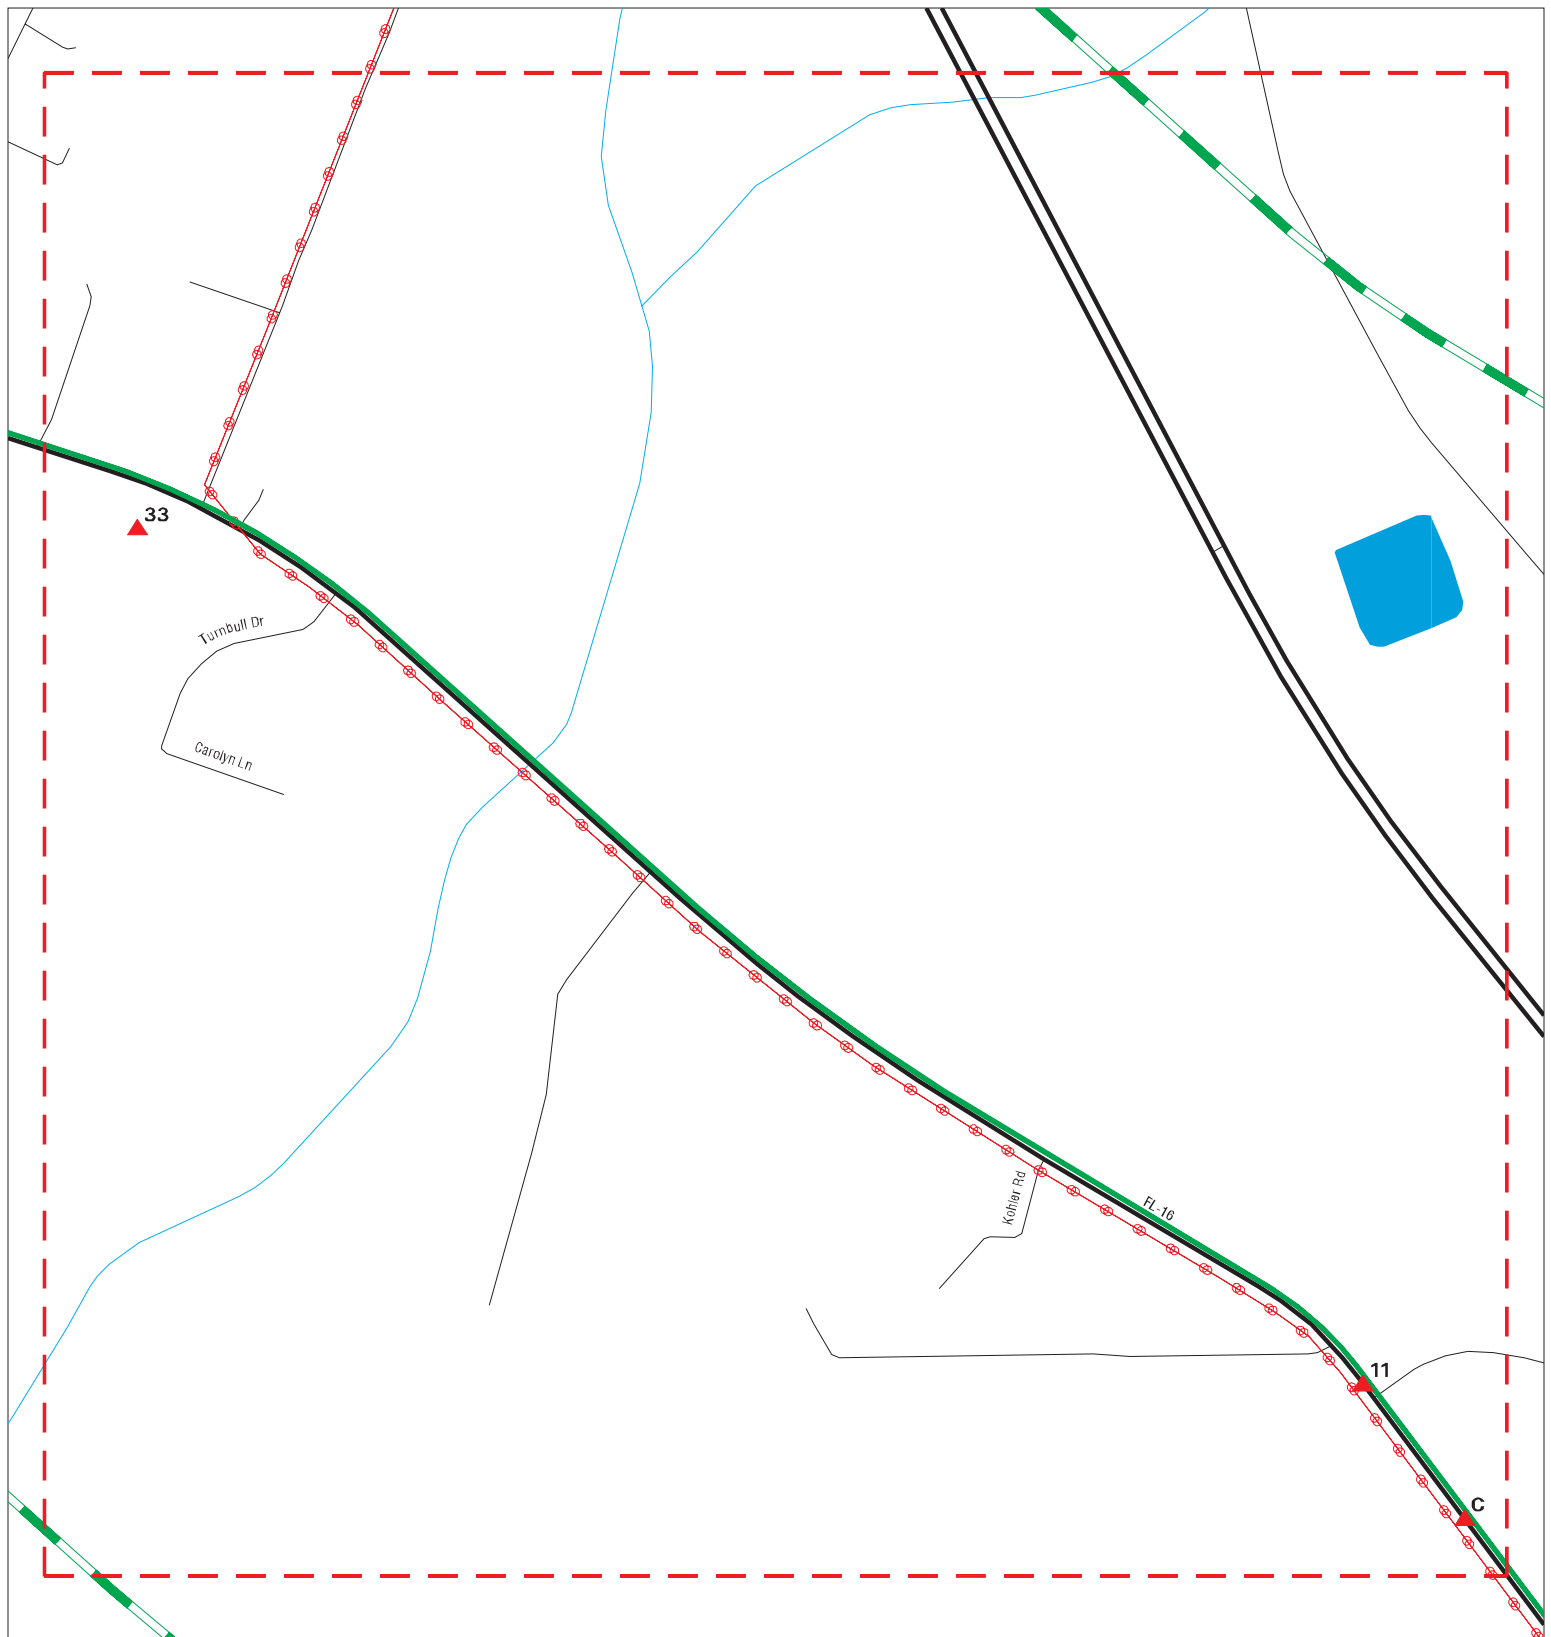
# Focus Map - 6 - 7458221.5s

| MAP ID /<br>FOCUS MAP | SITE NAME | ADDRESS | DATABASE ACRONYMS | DIST (ft. & mi.)<br>DIRECTION | | |
|---|---|---|---|---|---|---|
| 59 / 5 | PUBLIX SUPER MARKET | 84 TURIN TERRACE | AST | 1059 | 0.201 | South |

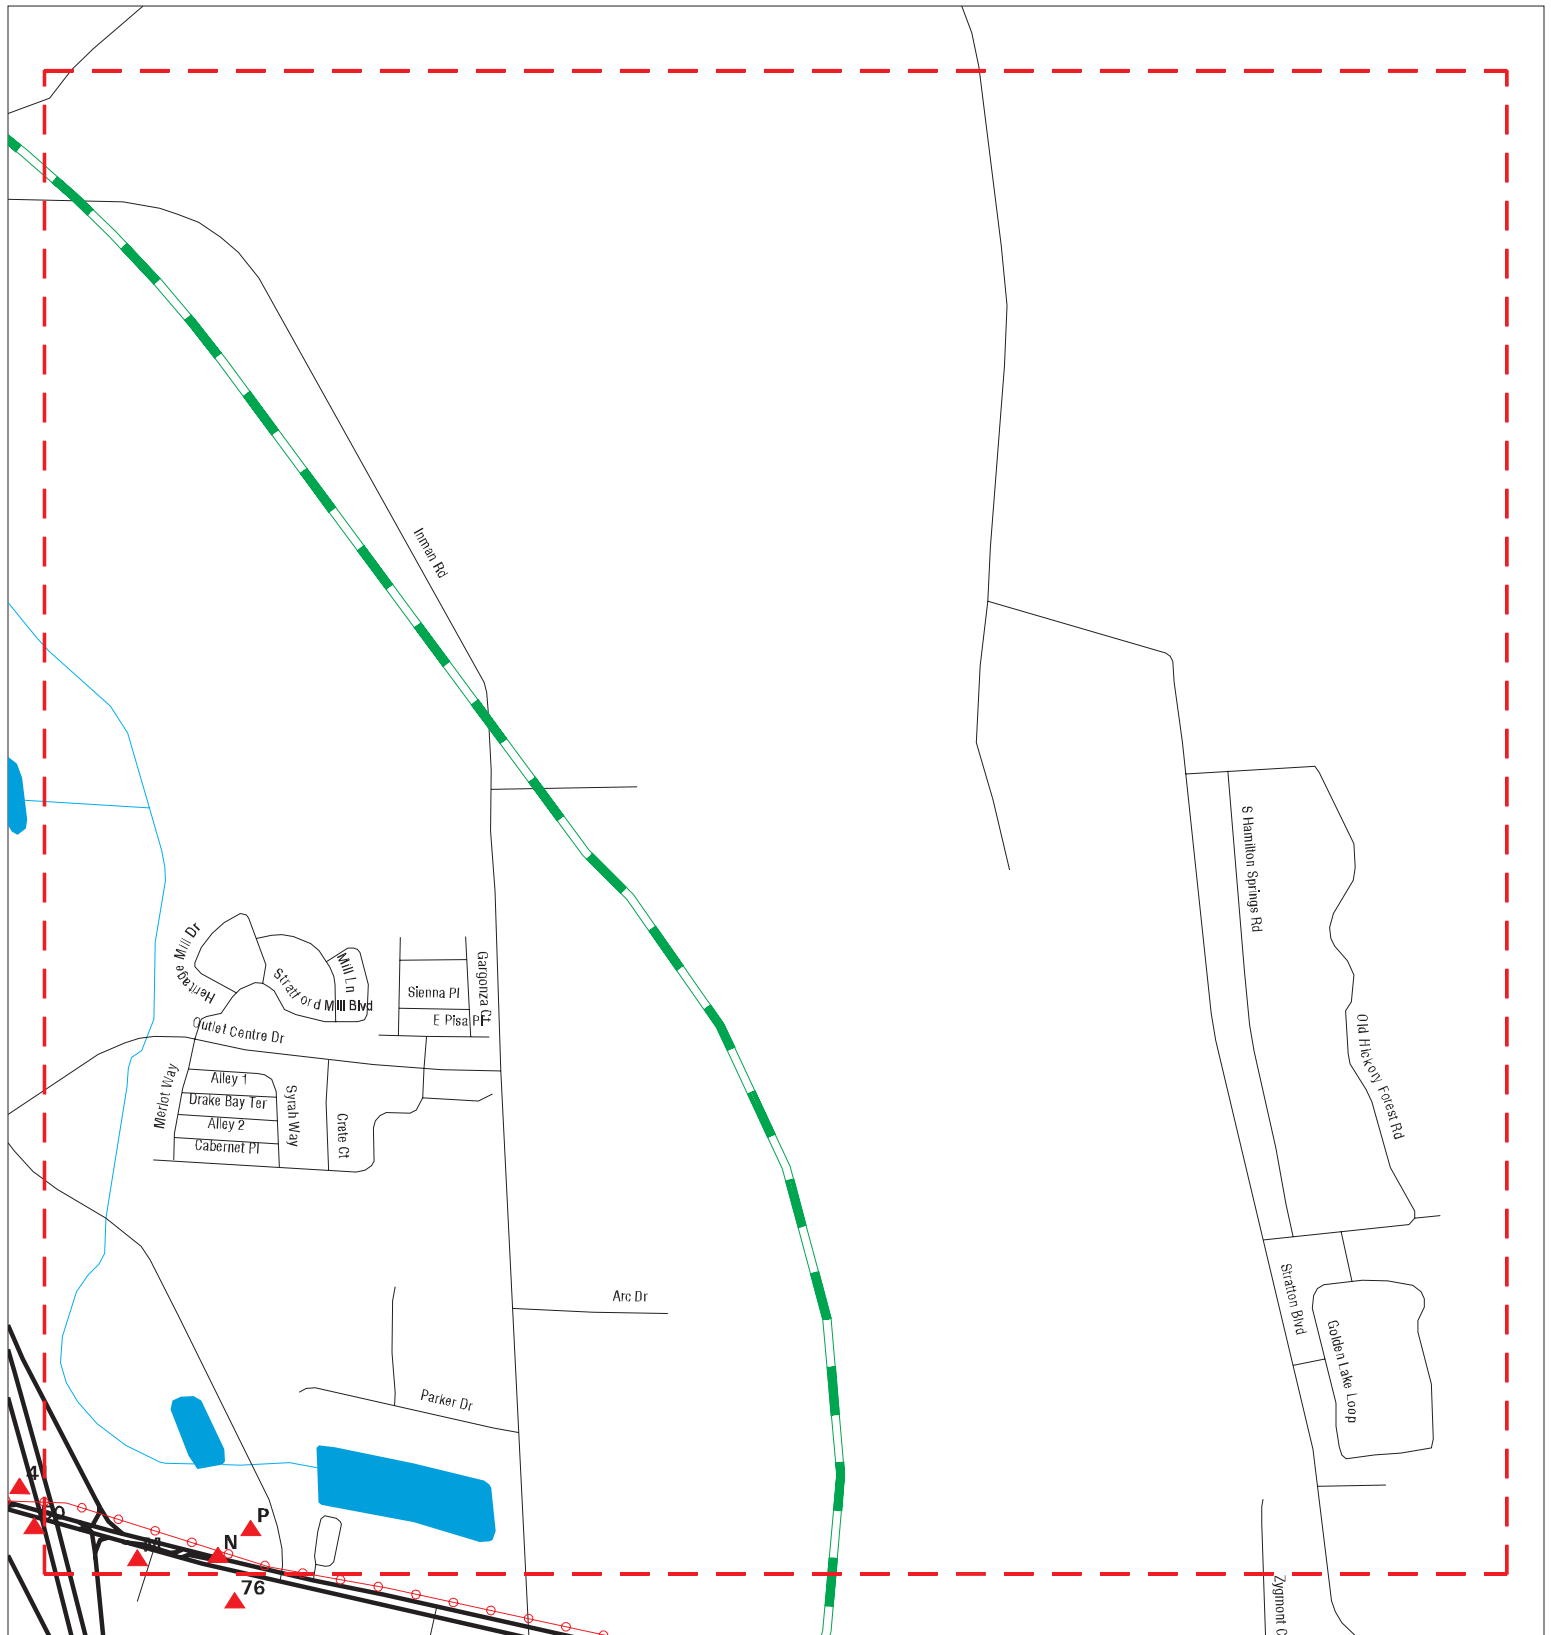
# Focus Map - 10 - 7458221.5s

| MAP ID /<br>FOCUS MAP | SITE NAME | ADDRESS | DATABASE ACRONYMS | DIST (ft. & mi.)<br>DIRECTION |
|---|---|---|---|---|
| 58 / 9 | CHARLES RUSINA | 2595 CR 208 | UST | 900 0.170 SW |

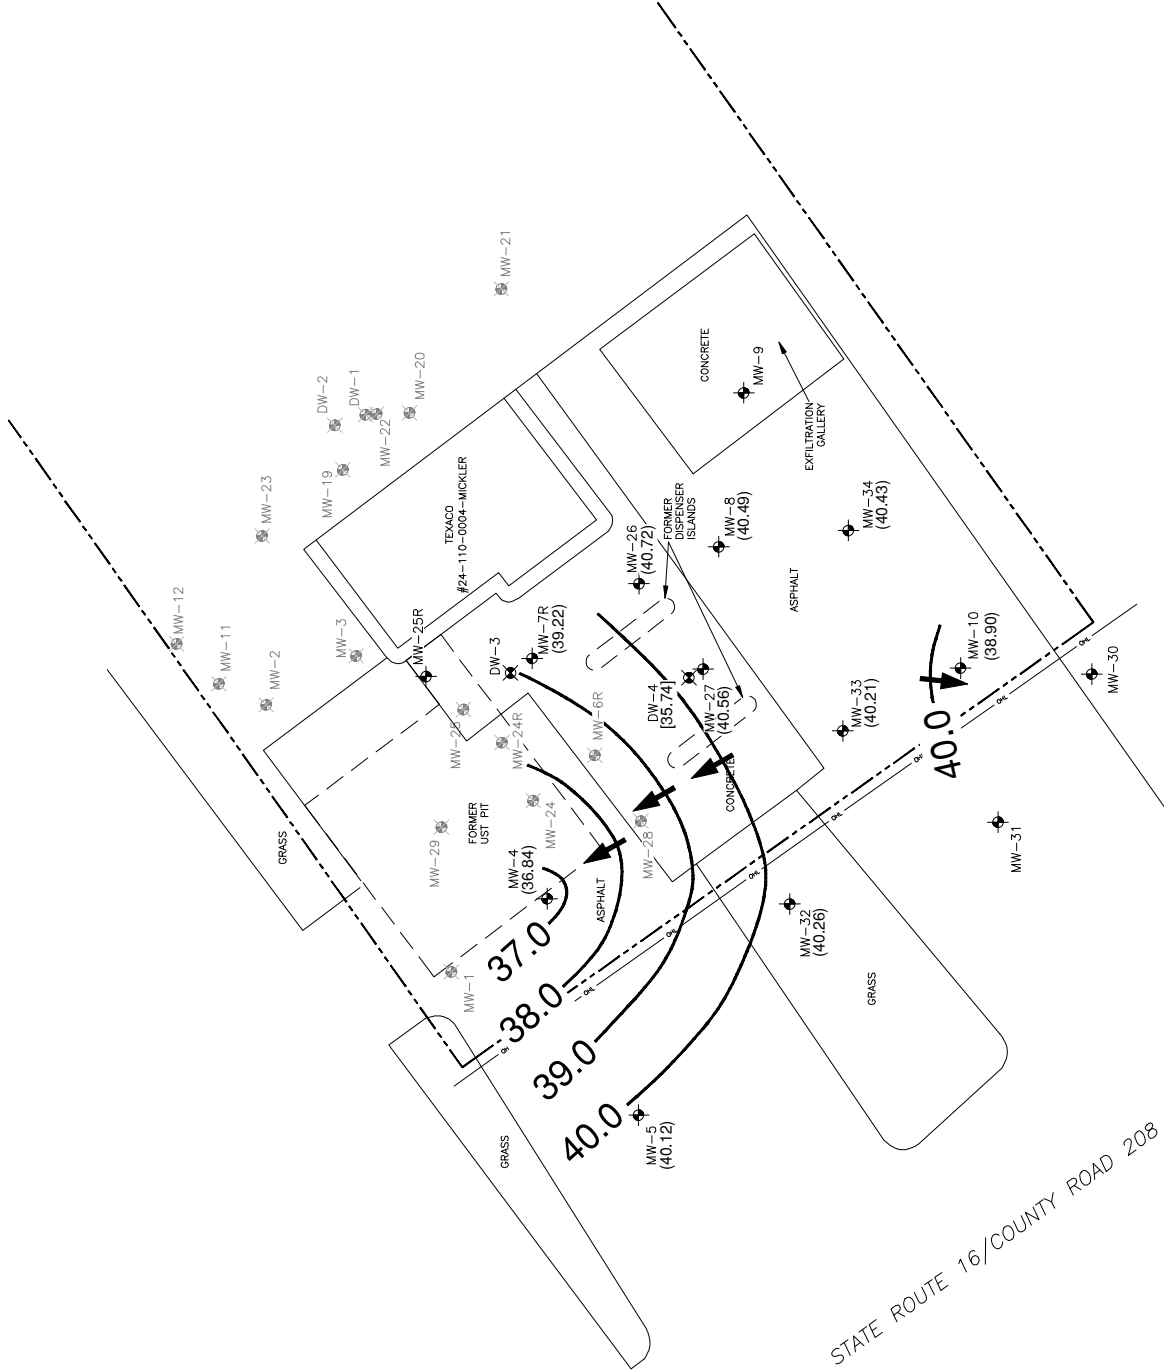
| FIGURE<br>3A | |

| DRAFTED BY:<br>KMM | WATER-TABLE ELEVATION CONTOUR MAP<br>JUNE 9, 2023 | | |
| CHECKED BY:<br>KD | TEXACO #24-110-0004-MICKLER<br>2500 HIGHWAY 16<br>ST. AUGUSTINE, ST. JOHNS COUNTY, FLORIDA | | |

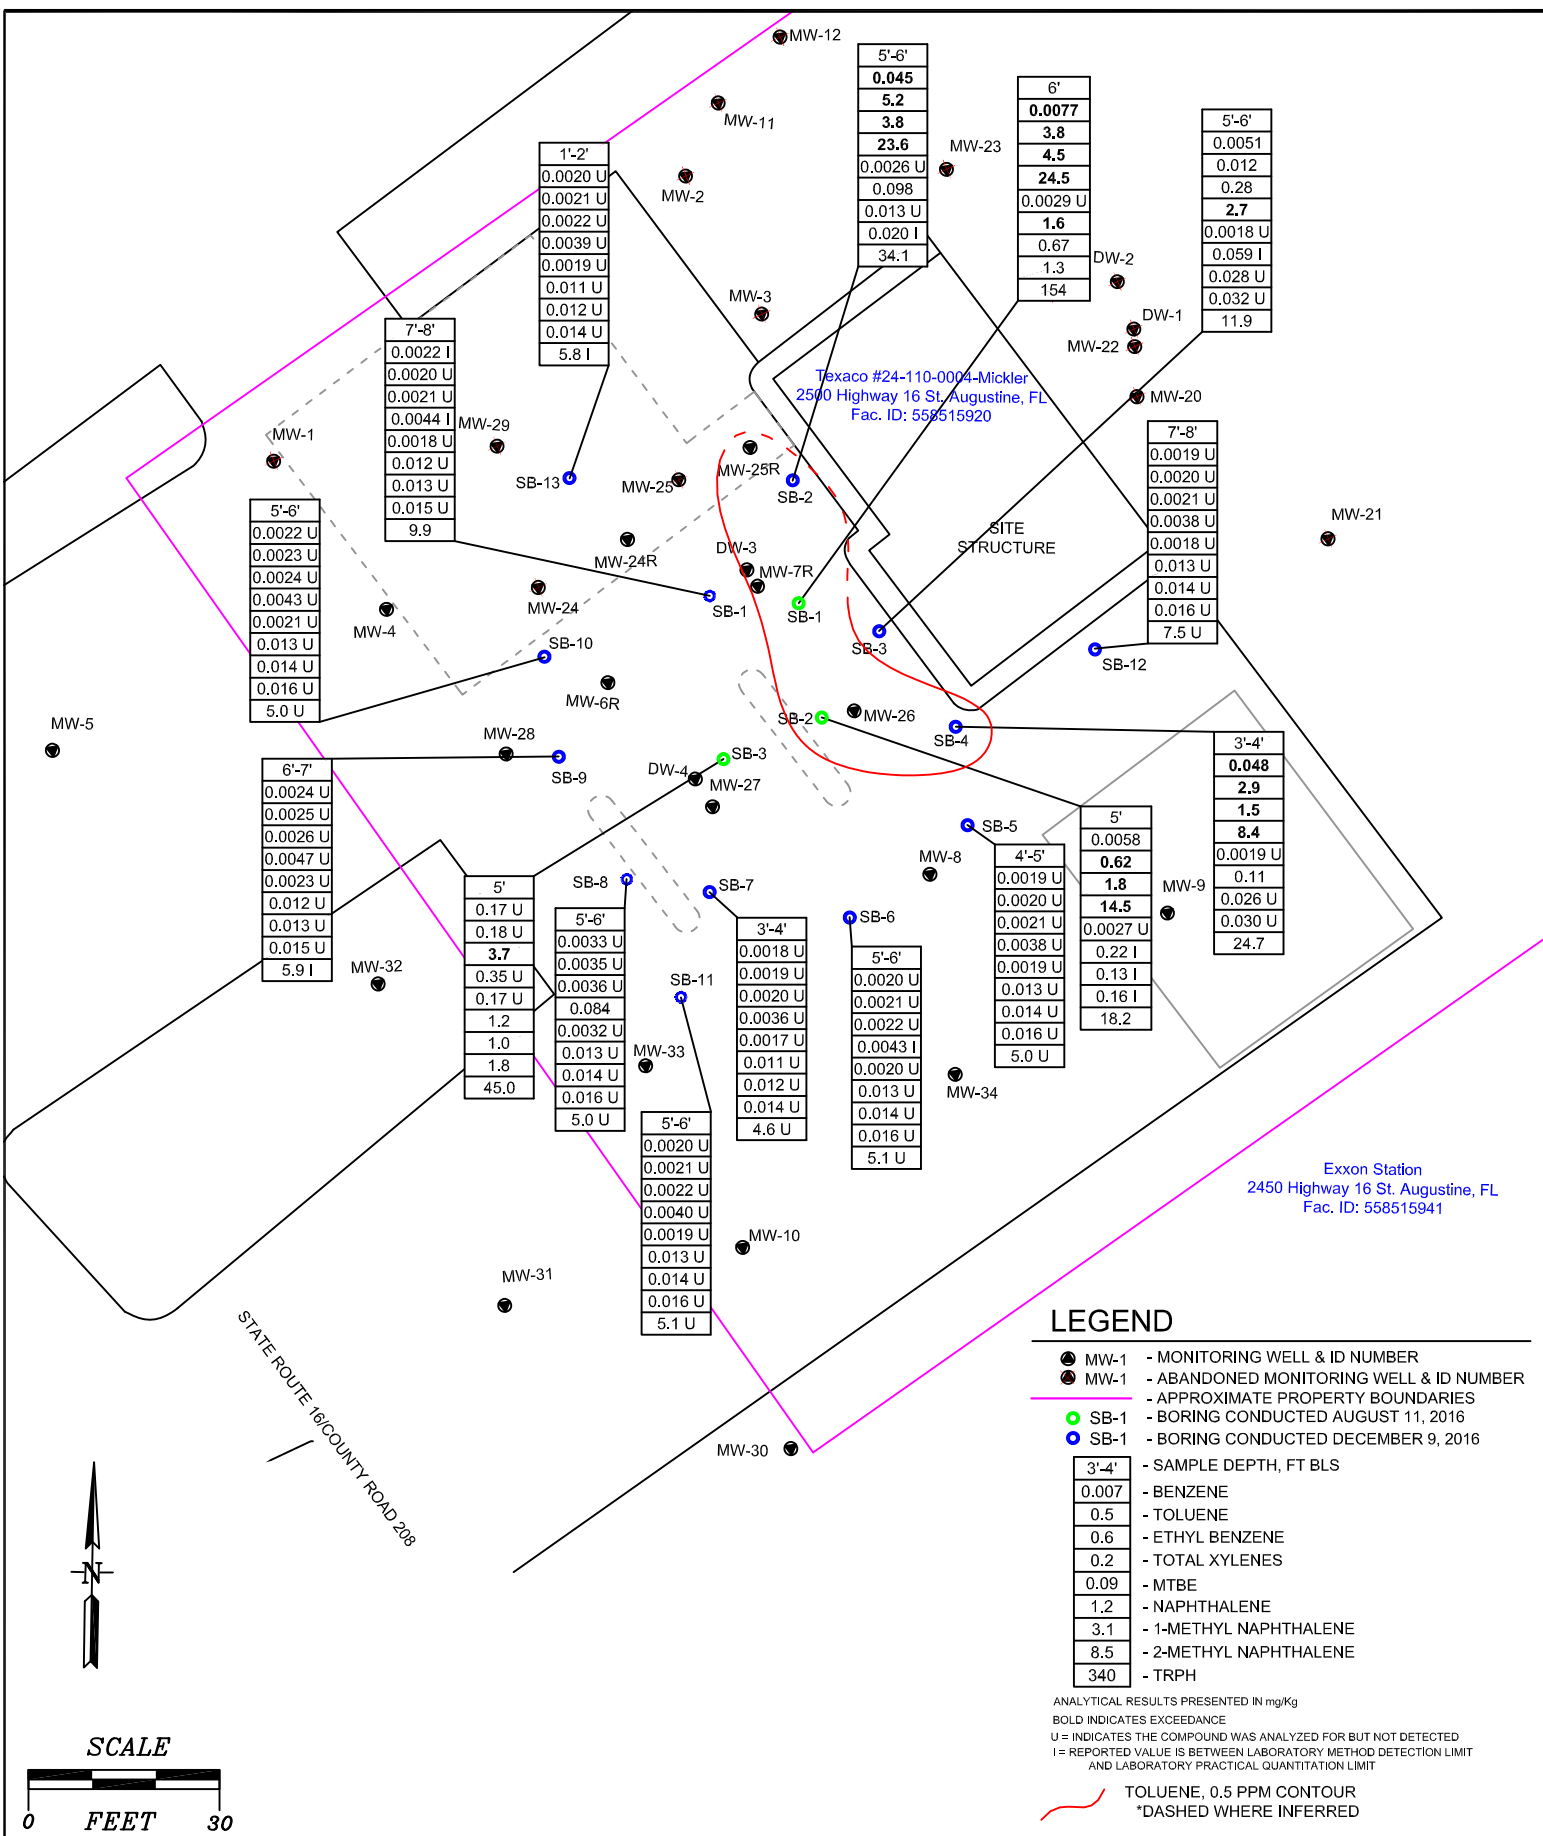
**FIGURE 5B**  
**SOIL HYDROCARBON DISTRIBUTION - TOLUENE**  
**TEXACO #24-110-0004-MICKLER**  
**FAC ID: 558515920**  
**ST. AUGUSTINE, FLORIDA**

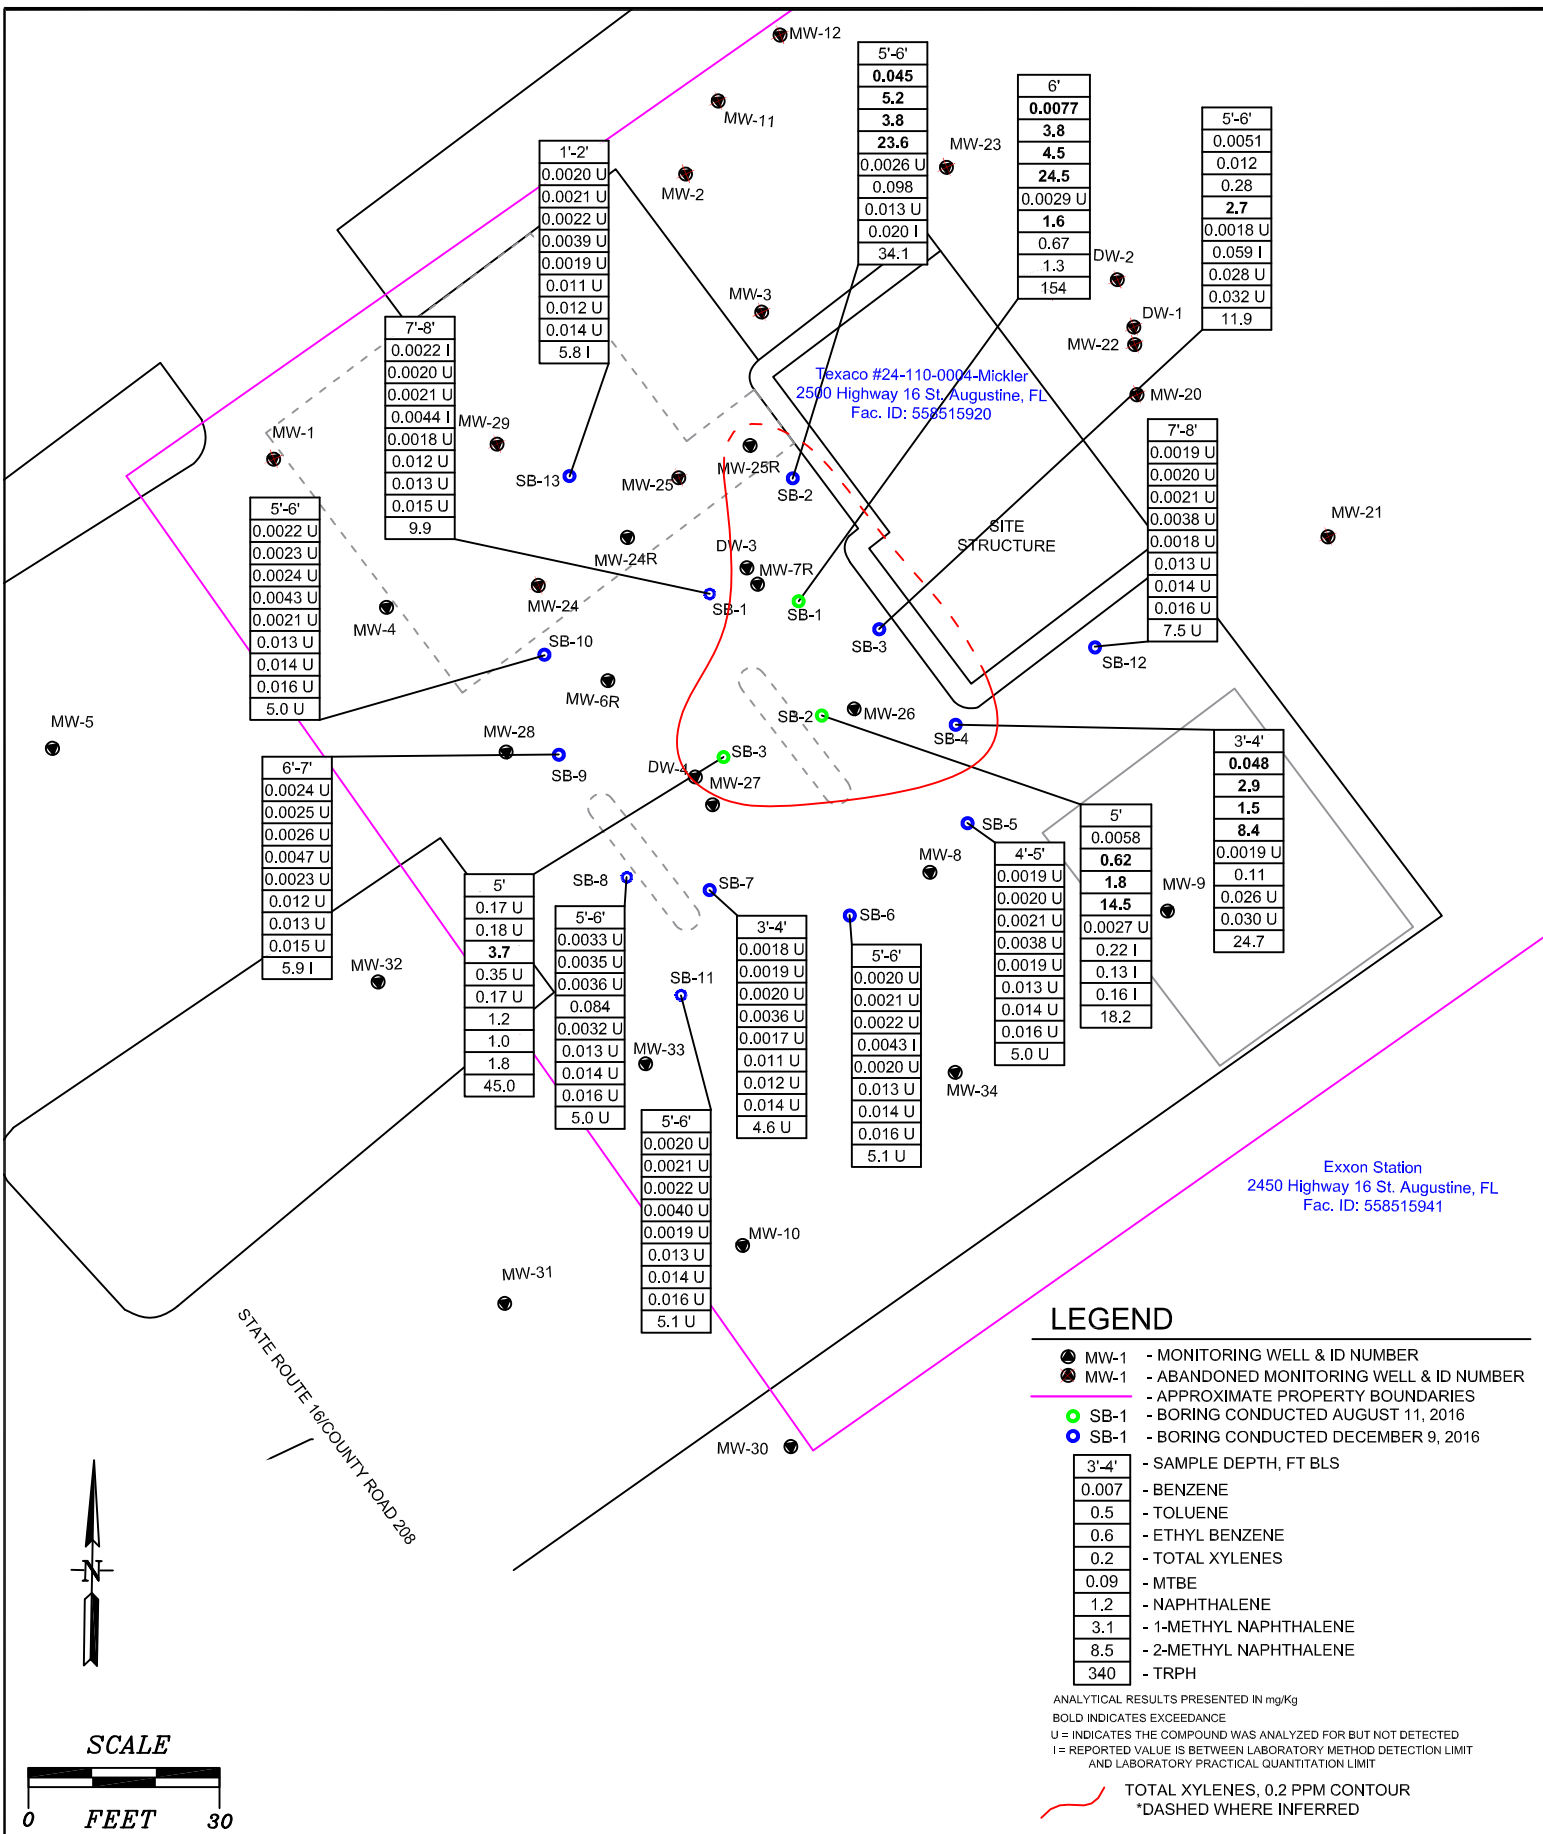
| <b>BY</b> <b>DATE</b><br>DRAWN BS 01/25/2017<br>CHECKED<br>APPROVED<br>APPROVED<br>APPROVED | | <b>FIGURE 5D</b><br><b>SOIL HYDROCARBON DISTRIBUTION - TOTAL XYLENES</b><br><b>TEXACO #24-110-0004-MICKLER</b><br><b>FAC ID: 558515920</b><br><b>ST. AUGUSTINE, FLORIDA</b> | |

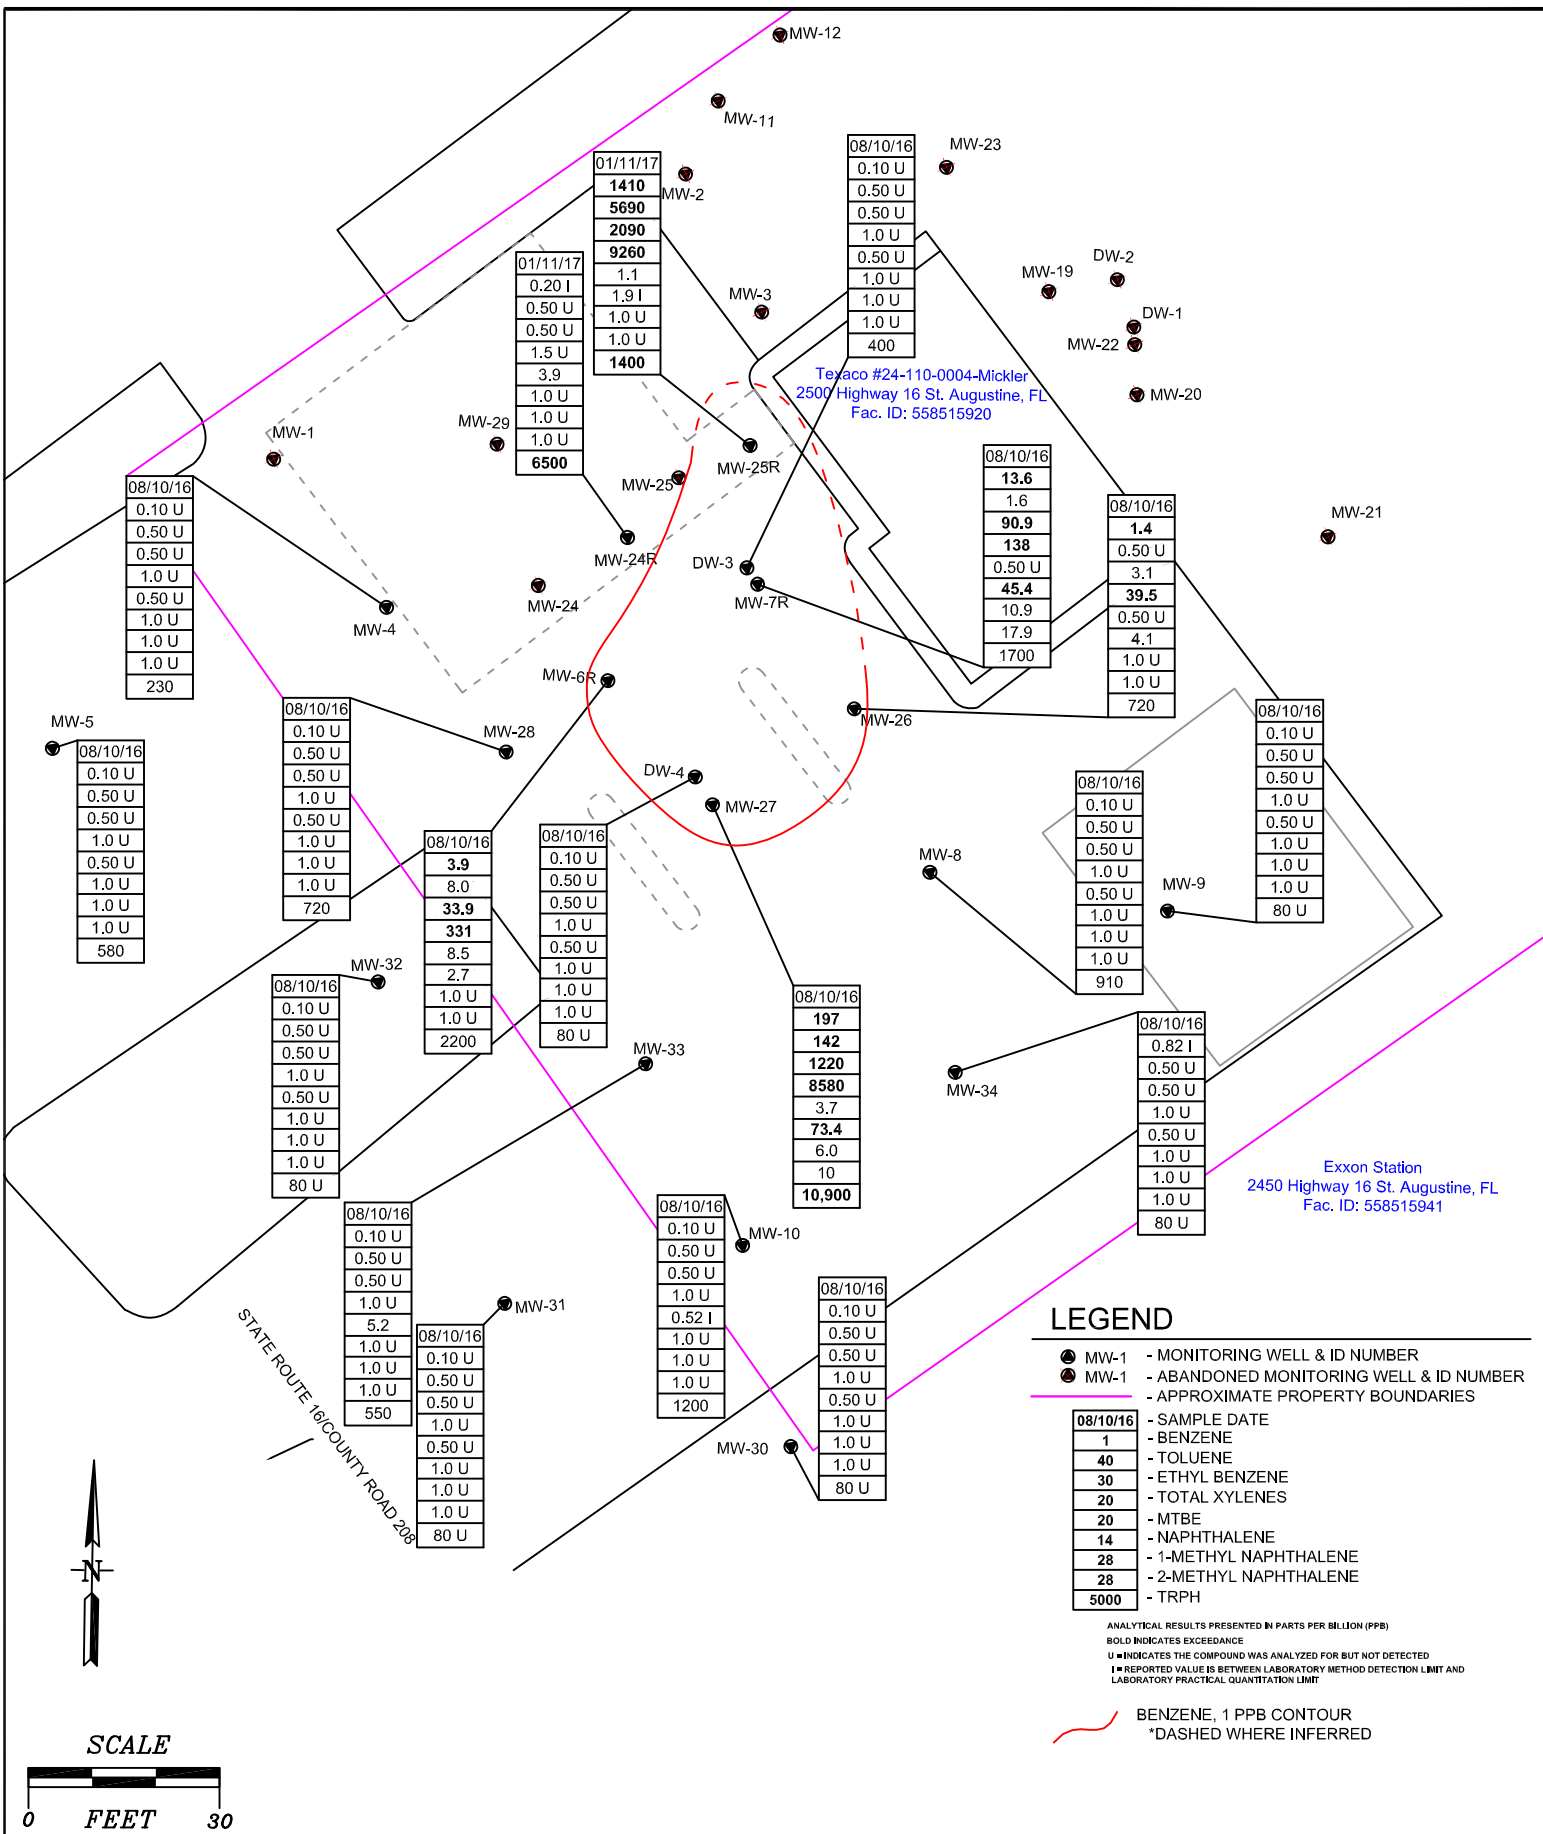
| <b>BY</b> <b>DATE</b><br>DRAWN    BS    01/25/2017<br>CHECKED<br>APPROVED<br>APPROVED<br>APPROVED | | <b>FIGURE 6A</b><br><b>GROUNDWATER HYDROCARBON DISTRIBUTION - BENZENE</b><br><b>TEXACO #24-110-0004-MICKLER</b><br><b>FAC ID: 558515920</b><br><b>ST. AUGUSTINE, FLORIDA</b> | |

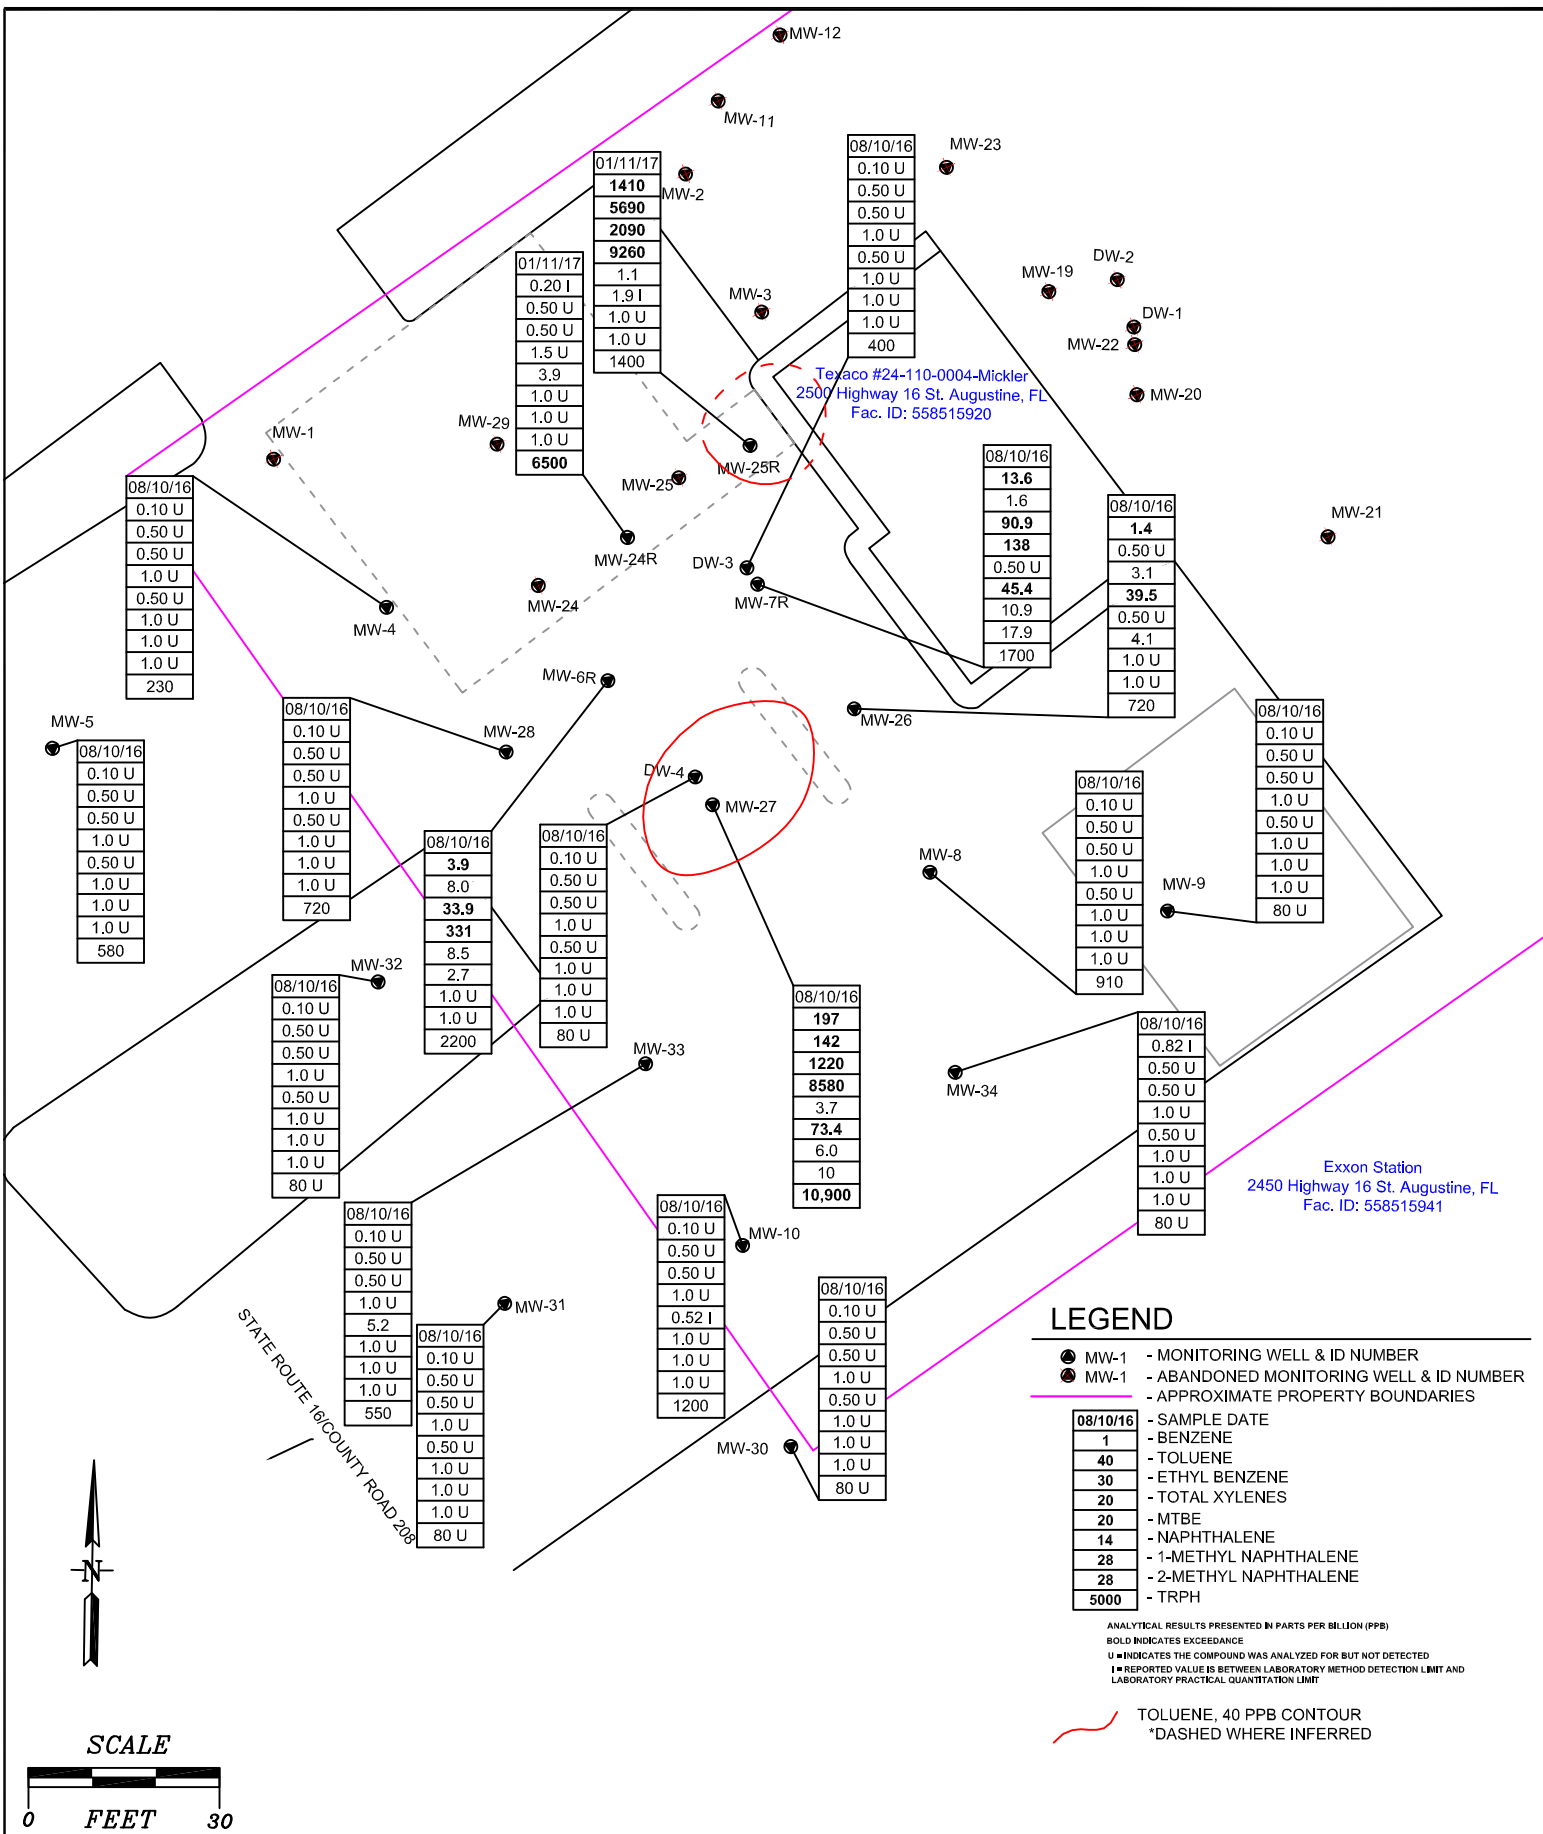
| <b>BY</b><br><b>DRAWN</b> BS<br><b>CHECKED</b><br><b>APPROVED</b><br><b>APPROVED</b><br><b>APPROVED</b> | | <b>DATE</b><br>01/25/2017 | | <b>FIGURE 6B</b><br><b>GROUNDWATER HYDROCARBON DISTRIBUTION - TOLUENE</b><br><b>TEXACO #24-110-0004-MICKLER</b><br><b>FAC ID: 558515920</b><br><b>ST. AUGUSTINE, FLORIDA</b> | |
