## **APPENDIX C**

### **ENVIRONMENTAL DATABASE REPORT**

**SR 16 From IGP To I-95**

September 29, 2023

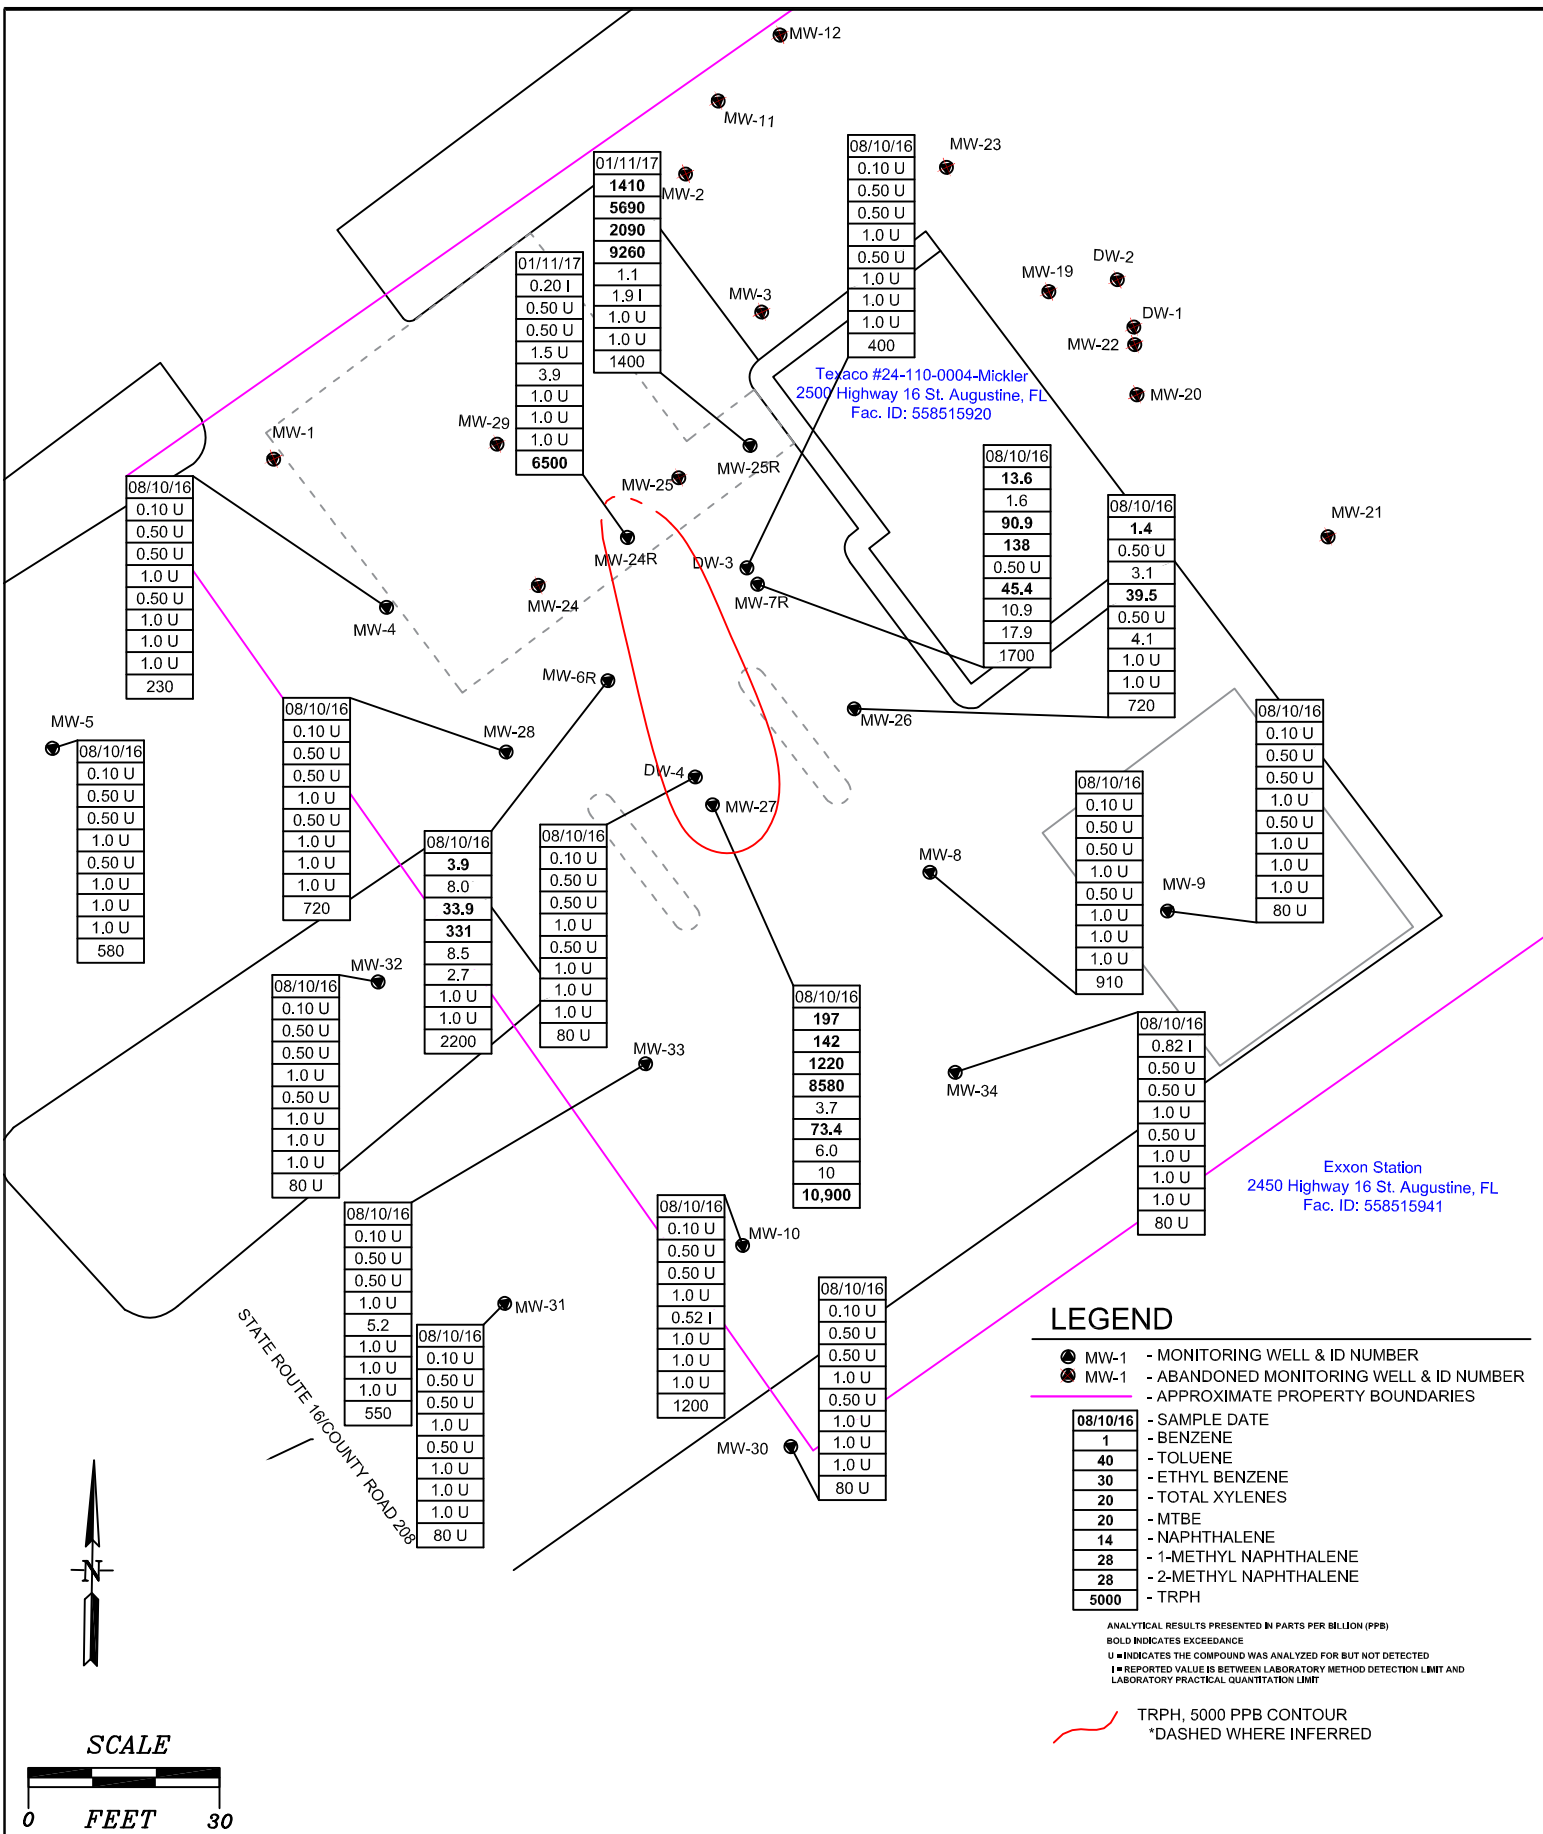
| <b>BY</b> | | <b>DATE</b> | | <div><b>Cameron-Cole</b><br/>200 E. GOVERNMENT STREET, SUITE 100<br/>PENSACOLA, FLORIDA 32502<br/>PHONE: 850-434-1011<br/>FAX: 850-434-2168<br/><a href="http://www.cameron-cole.com">http://www.cameron-cole.com</a></div> | <b>FIGURE 6F</b> | | |
| <b>DRAWN</b> | BS | 01/25/2017 | | | <b>GROUNDWATER HYDROCARBON DISTRIBUTION - TRPH</b> | | |

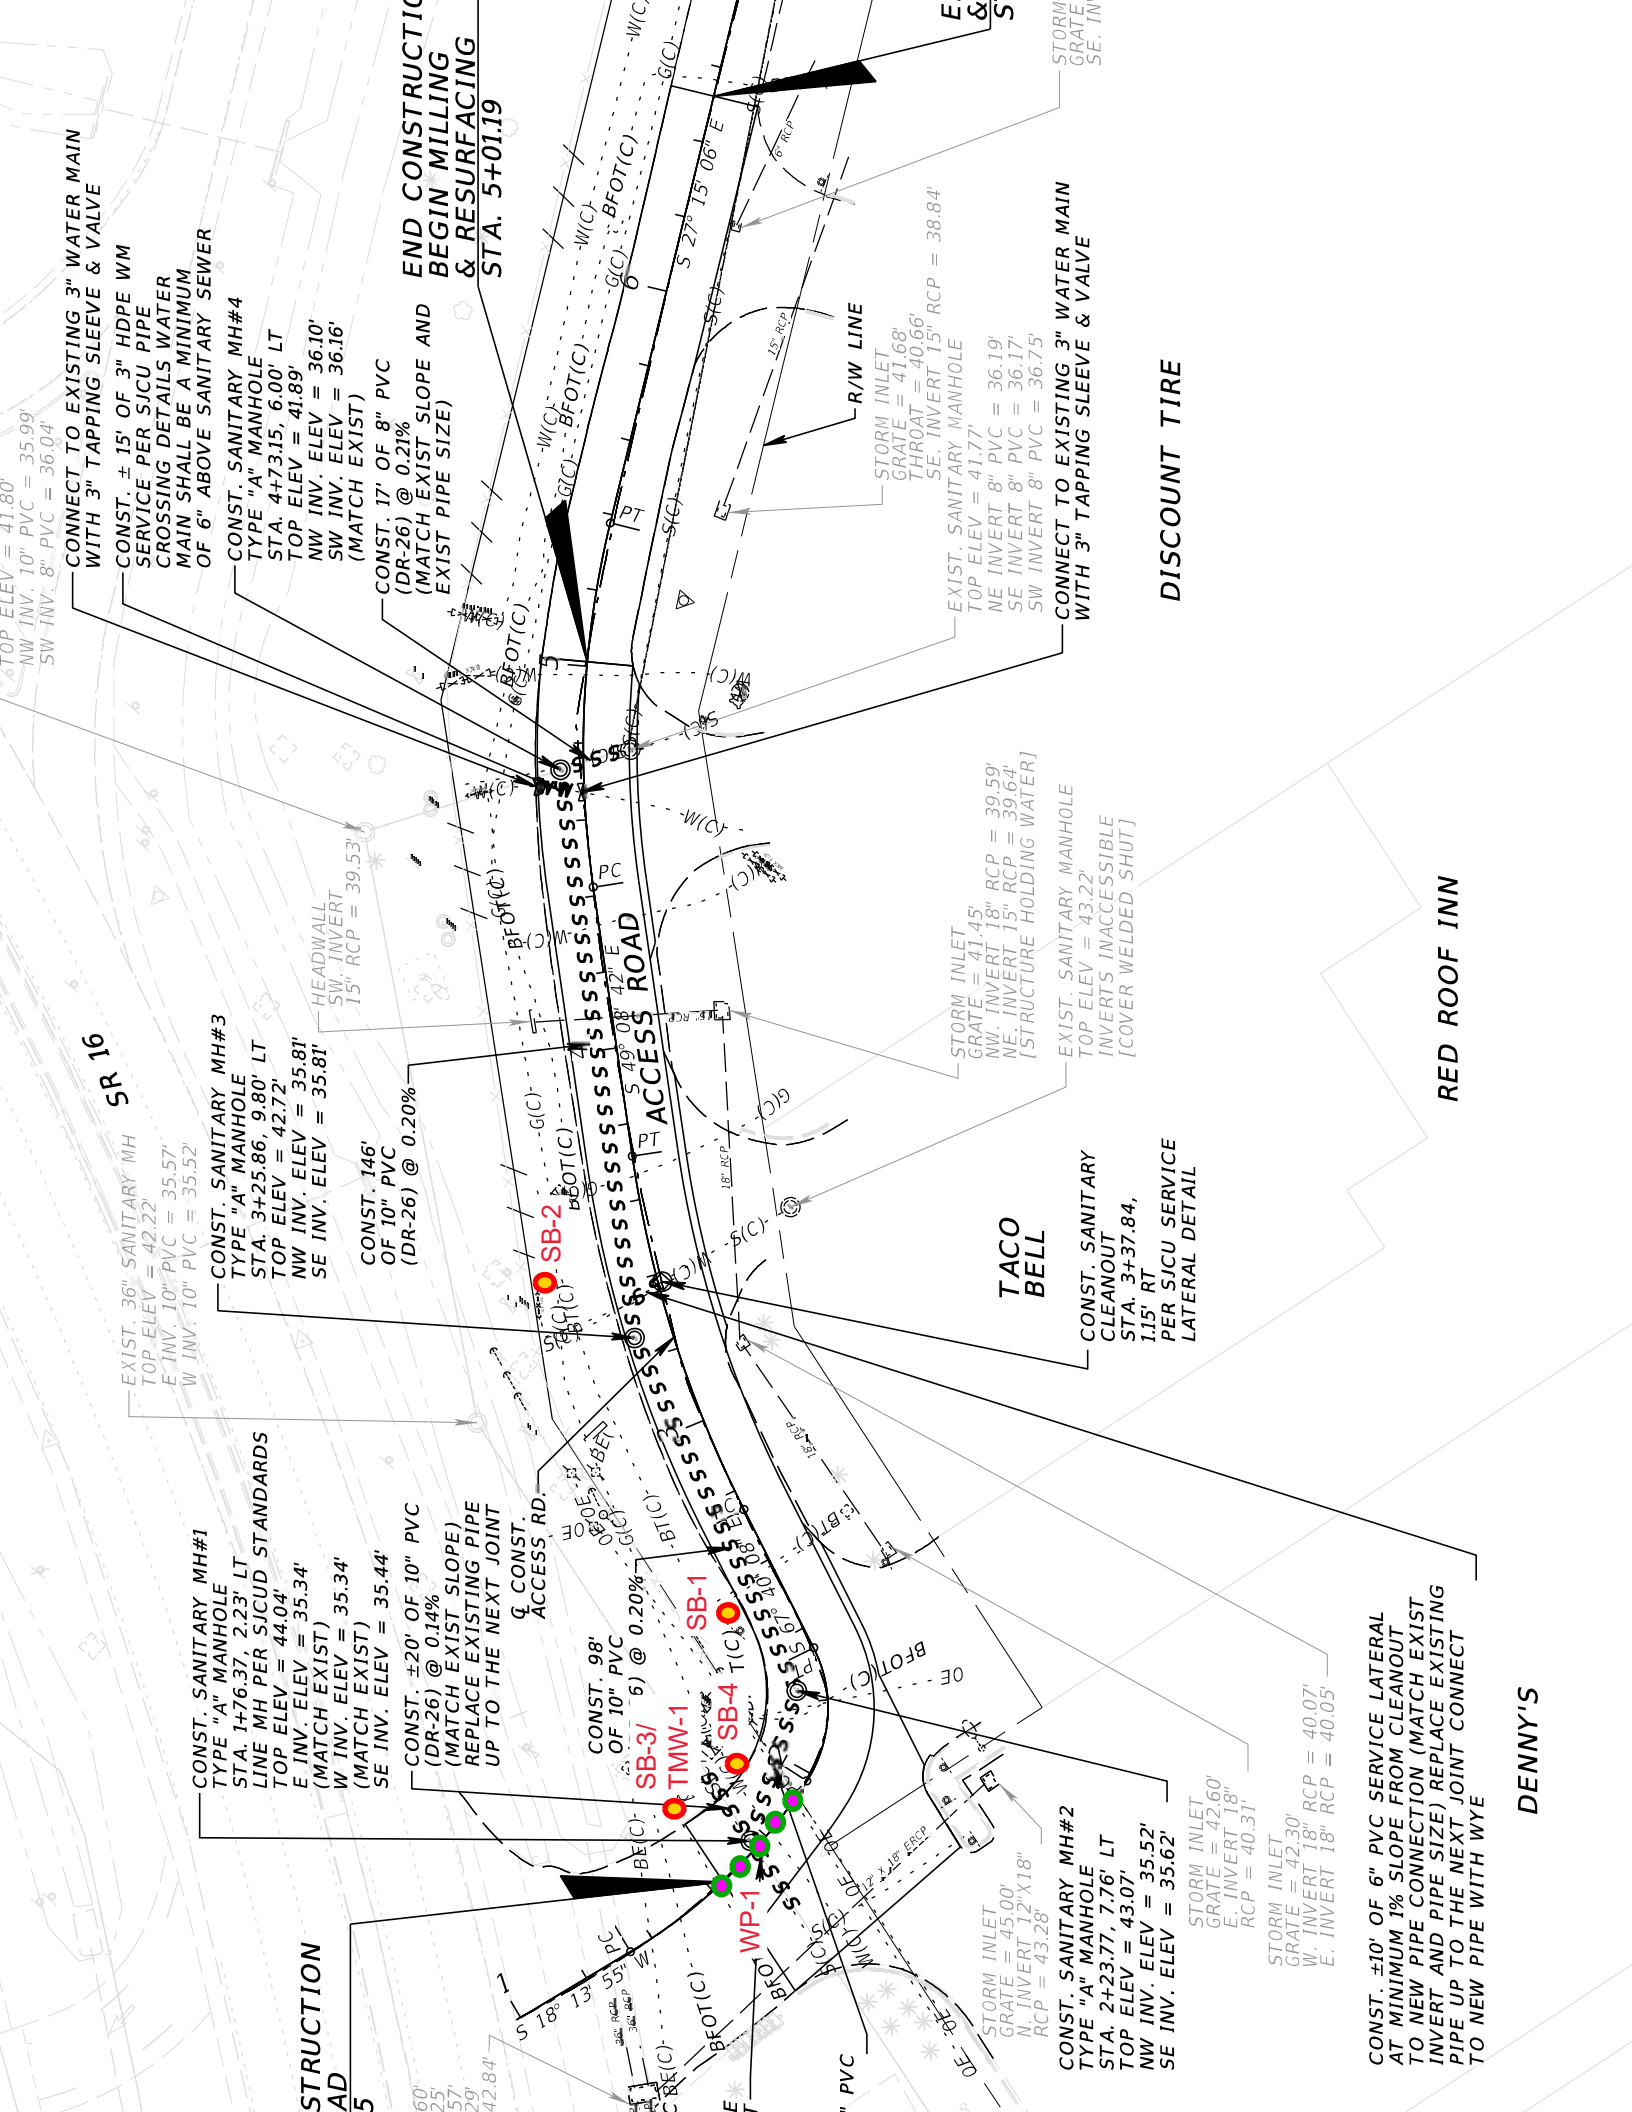
TOP ELEV. = 41.80'  
NW INV. 10" PVC = 35.99'  
SW INV. 8" PVC = 36.04'

CONNECT TO EXISTING 3" WATER MAIN  
WITH 3" TAPPING SLEEVE & VALVE  
CONST. ± 15' OF 3" HDPE WM  
SERVICE PER SJCU PIPE  
CROSSING DETAILS WATER  
MAIN SHALL BE A MINIMUM  
OF 6" ABOVE SANITARY SEWER

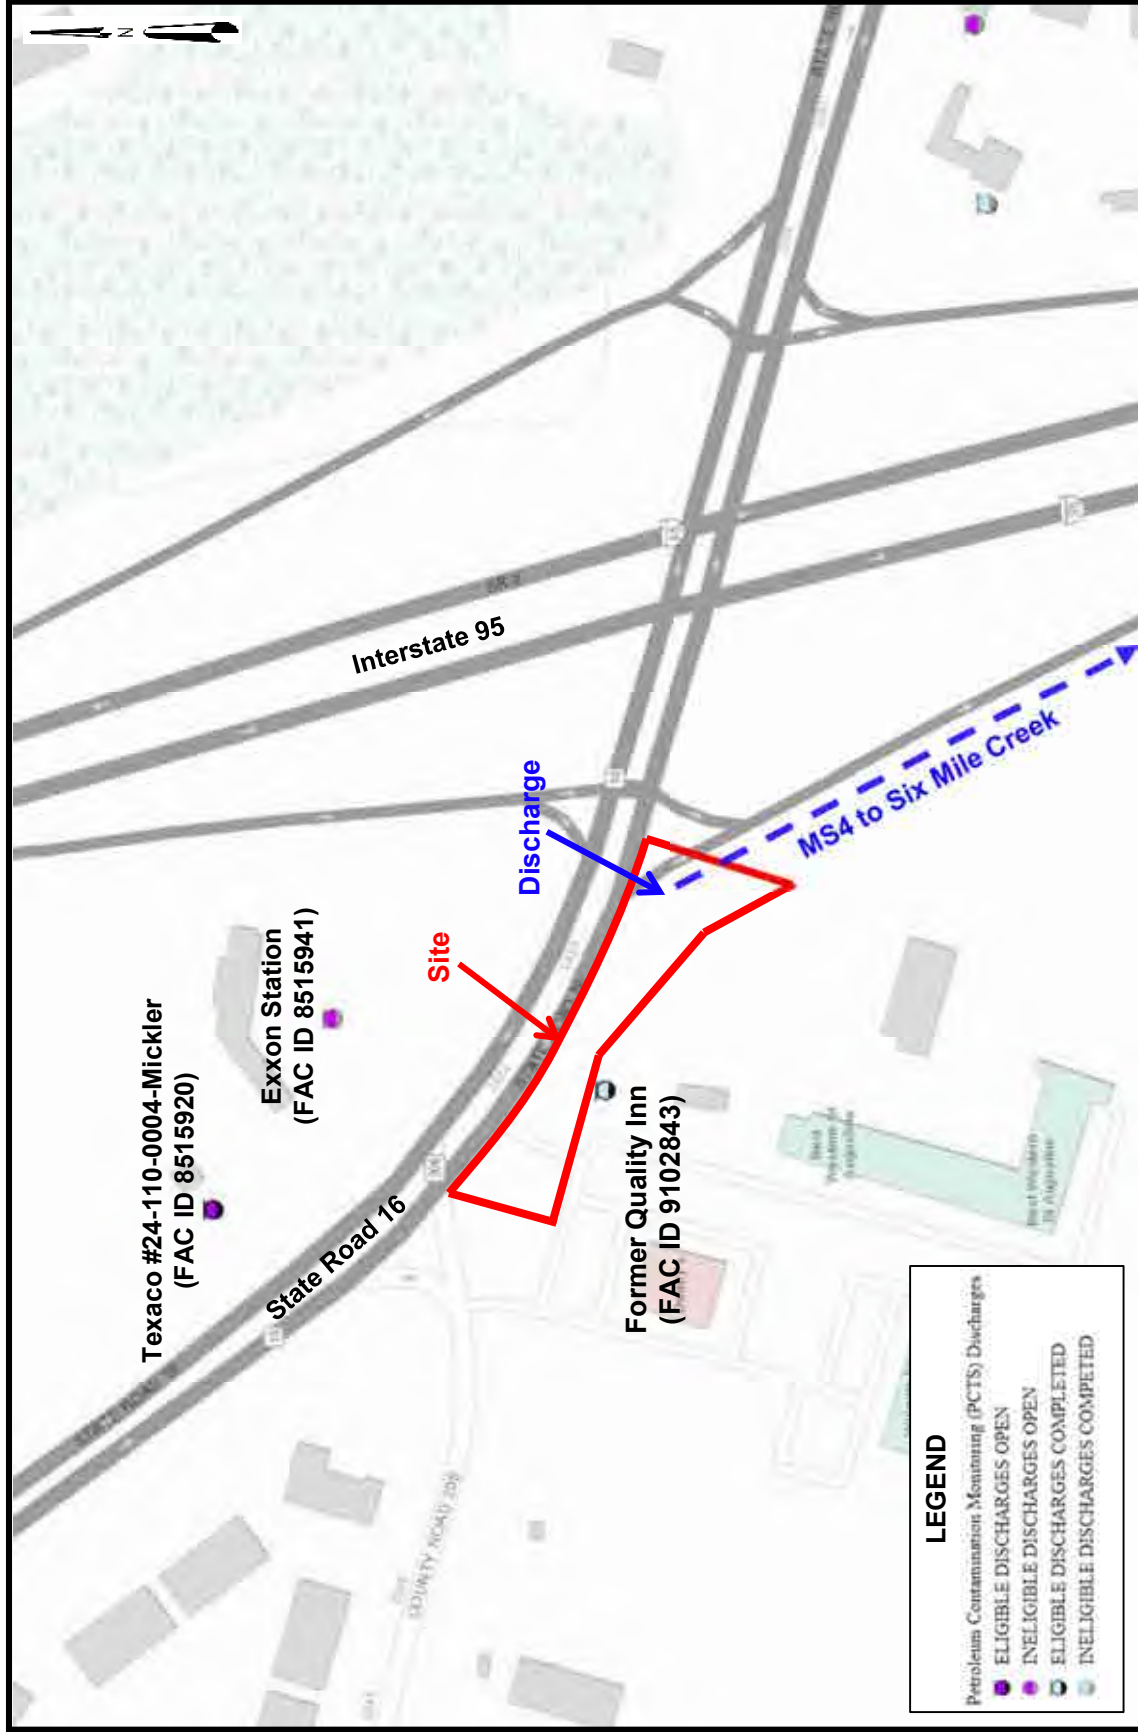
| <b>Figure 1</b> | <b>FDOT 2 ROW near Former Quality Inn<br/>(2445 SR 16, FAC ID 9102843)</b><br>Treated Discharge Flow Paths<br>St. Augustine, St. Johns County, Florida | <b>Project No.:</b> 631022211<br><b>Date:</b> 11/09/2021<br><b>Base Map:</b> FDEP Map Direct |
